INDIAN ARCHAEOLOGY 2006-07

- A Review

PUBLISHED BY
THE DIRECTOR GENERAL
ARCHAEOLOGICAL SURVEY OF INDIA
JANPATH, NEW DELHI
2016

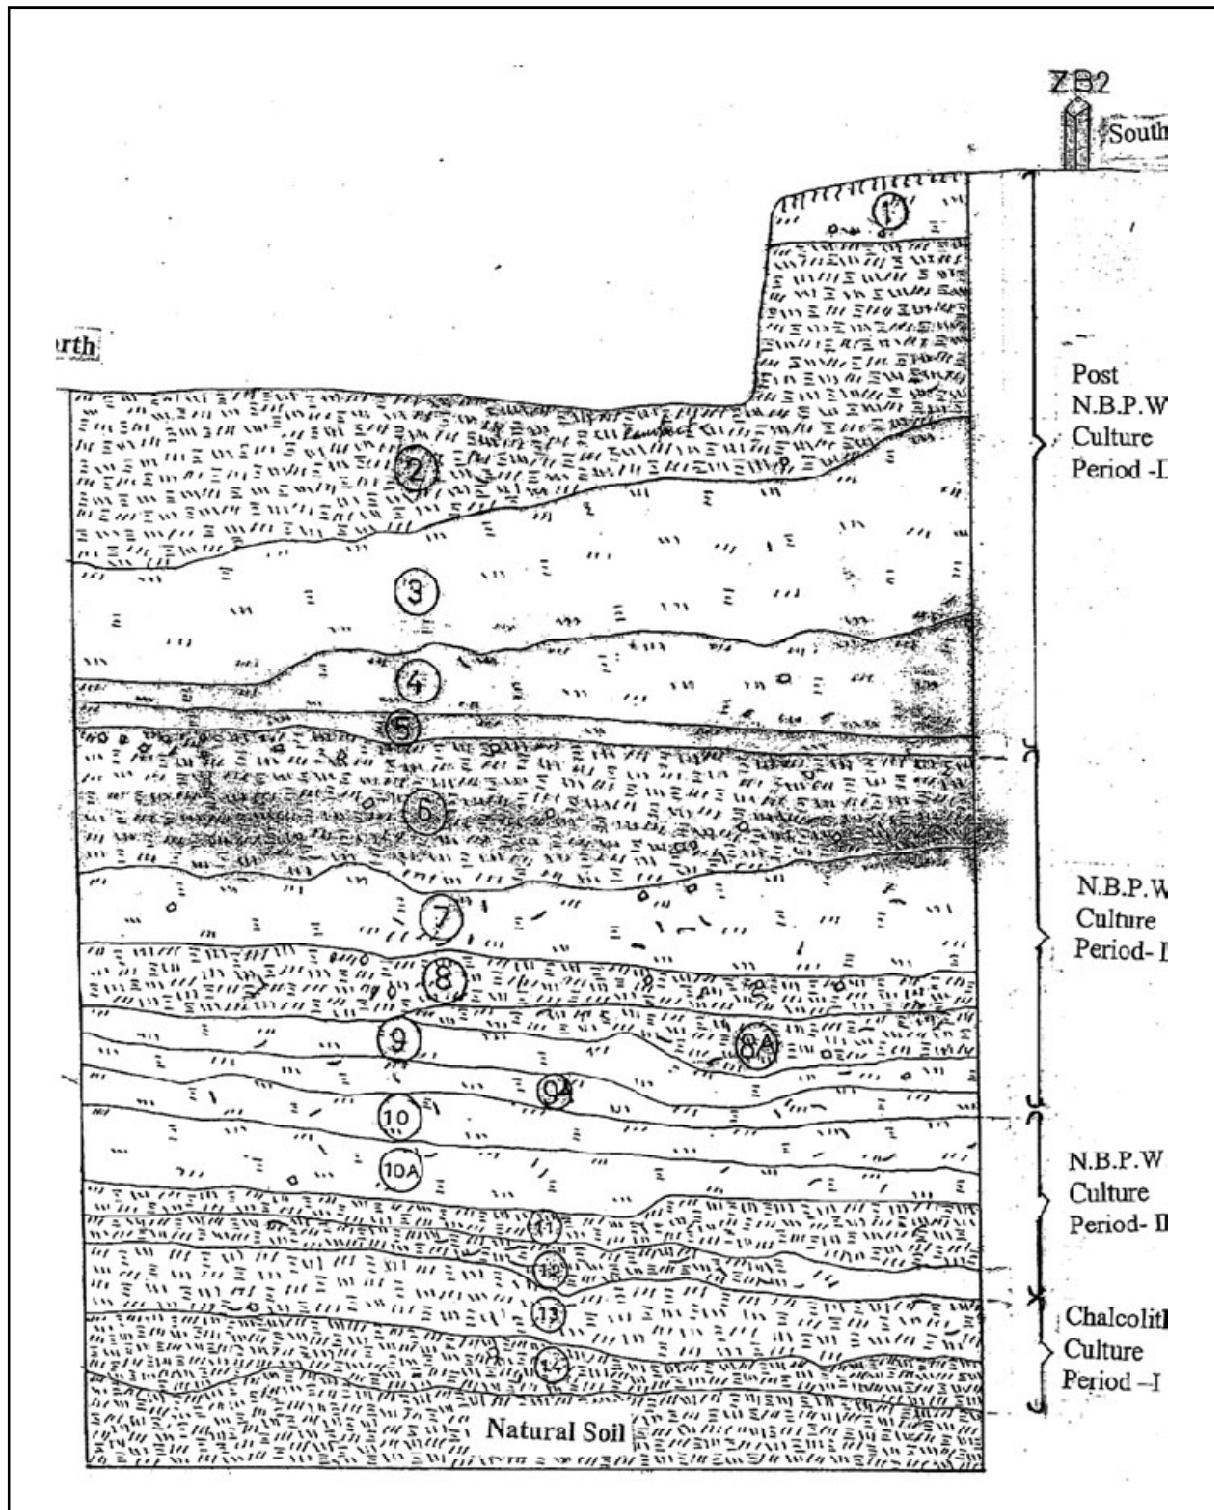
Fig.1: Juafardih: excavated section showing successive periods. See p.6

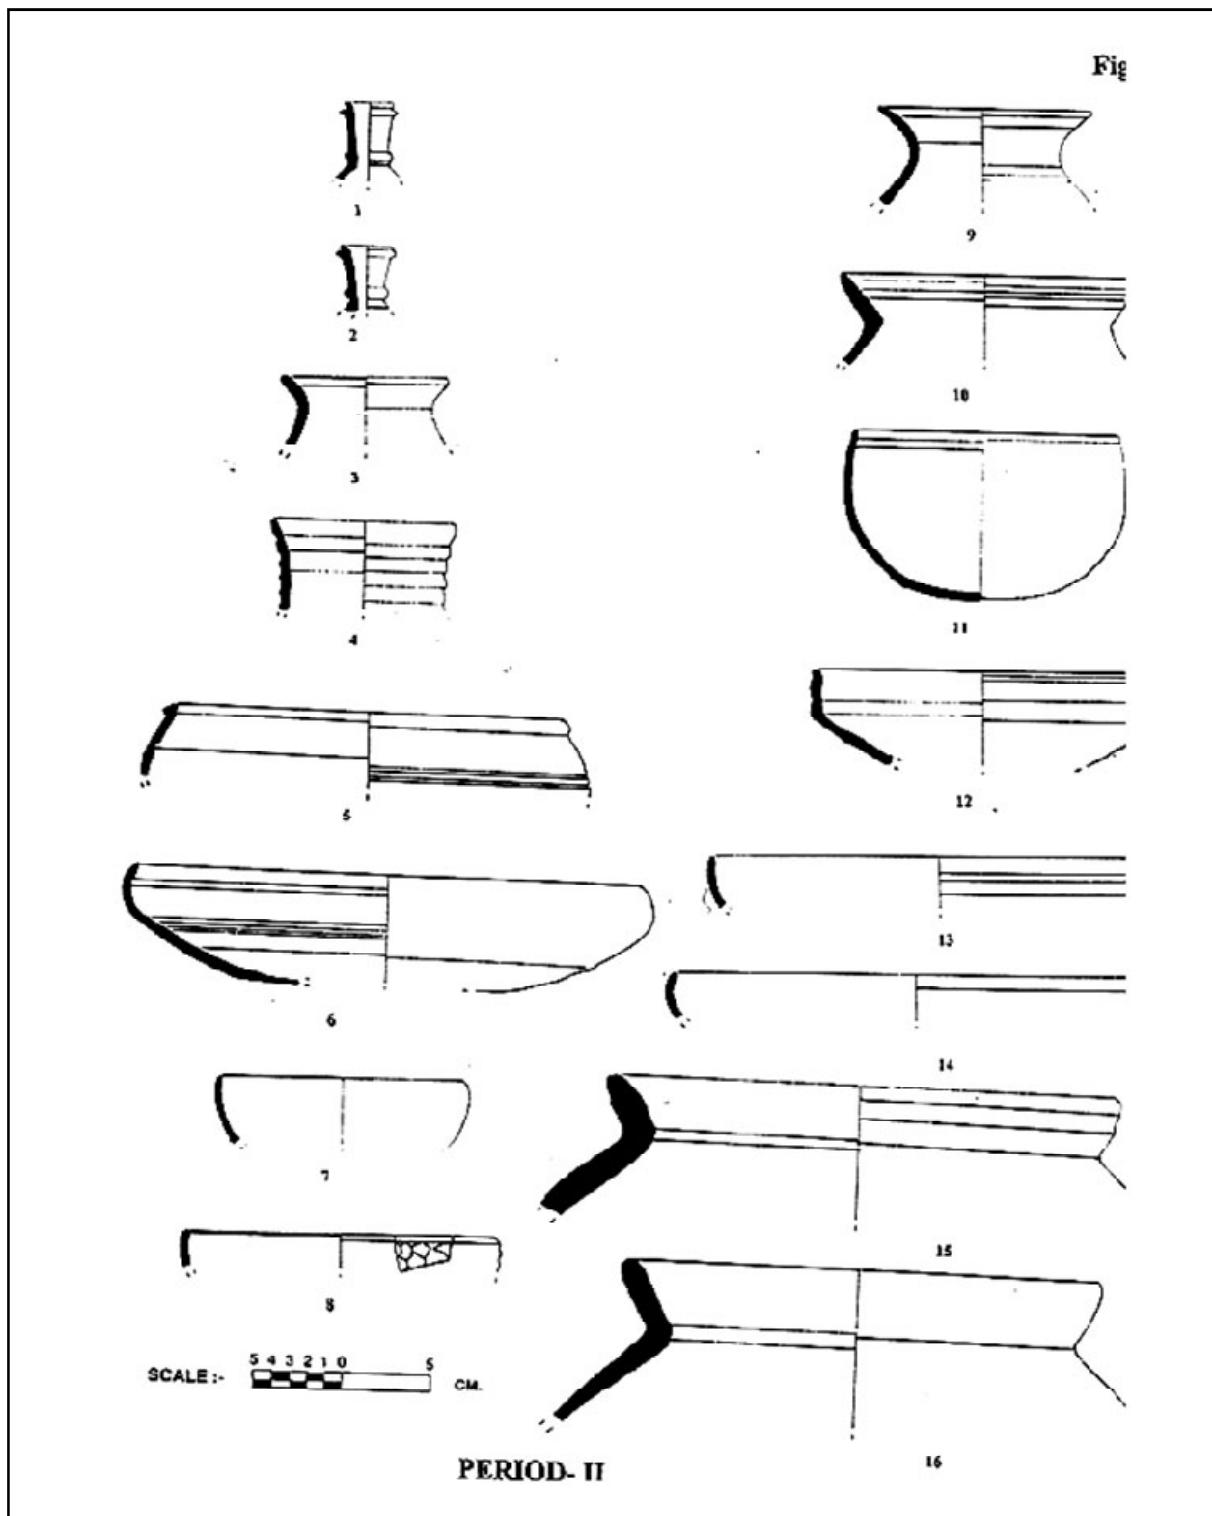
Fig. 2: Juafardih: NBPW and othe associated pottery. See p.6

potsherds of Chalcolithic black and red ware, black slipped ware and red ware. Bowls, dishes and vases are the common shapes of this period. Due to limited scope of excavation, no antiquity was found. Period II had a total deposit of 10.61m including the height of mud stupa. The total habitational deposit of Period II was 3.44m (excluding the packing of mud stupa). In the Period II at the NBPW level in the trenches, a good number of wattle and daub impressed burnt clay pieces have been encountered in the Layers 6, 7, and 8. It indicates the structural activities of the NBPW period. Some consecutive floors with postholes are also noticed in the Trenches in the Layers 6, 7, 8 and 9. In this period, ceramic industries marked with lustrous polished pottery popularly known as NBPW. The NBPW of this period are very fine fabric with thin section. Other ceramic assemblages are black slipped ware, red slipped ware, red ware and grey ware (Figs. 2-4).

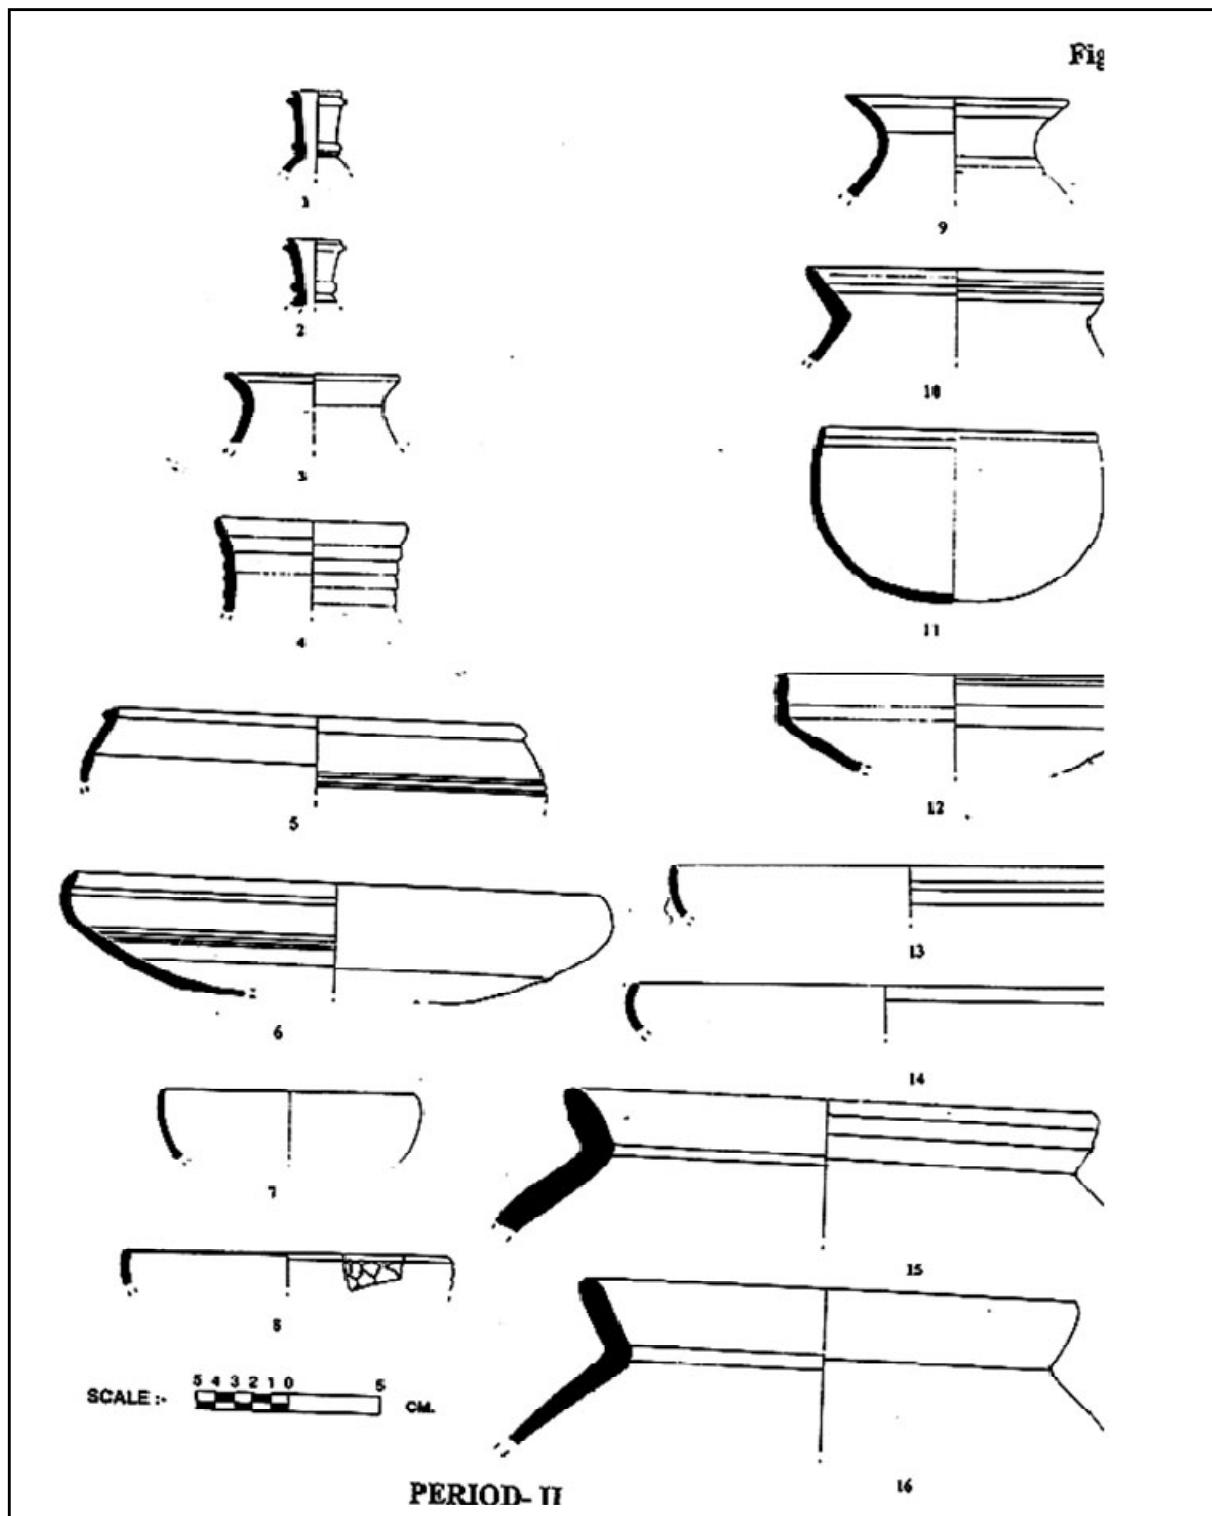
Fig.3: Juafardih: NBPW and other associated vases. See p.6

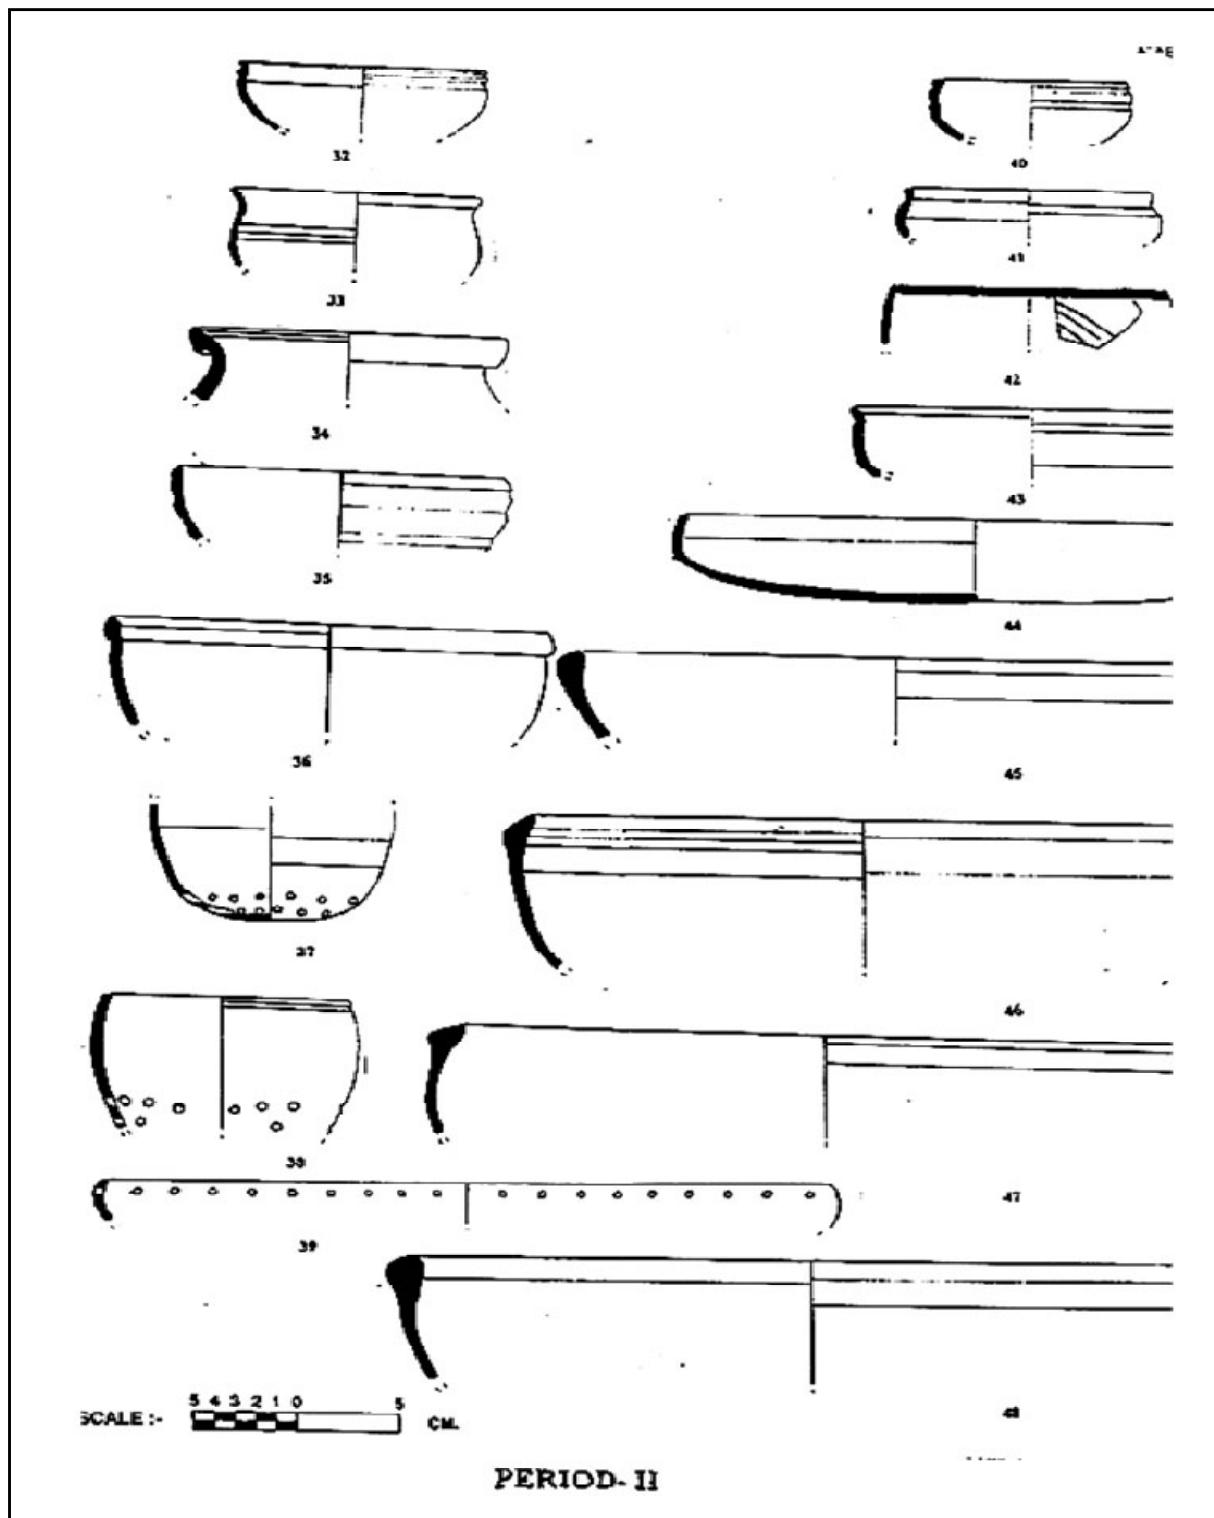
Fig.4: Juafardih: NBPW and other associated potteries. See p.6

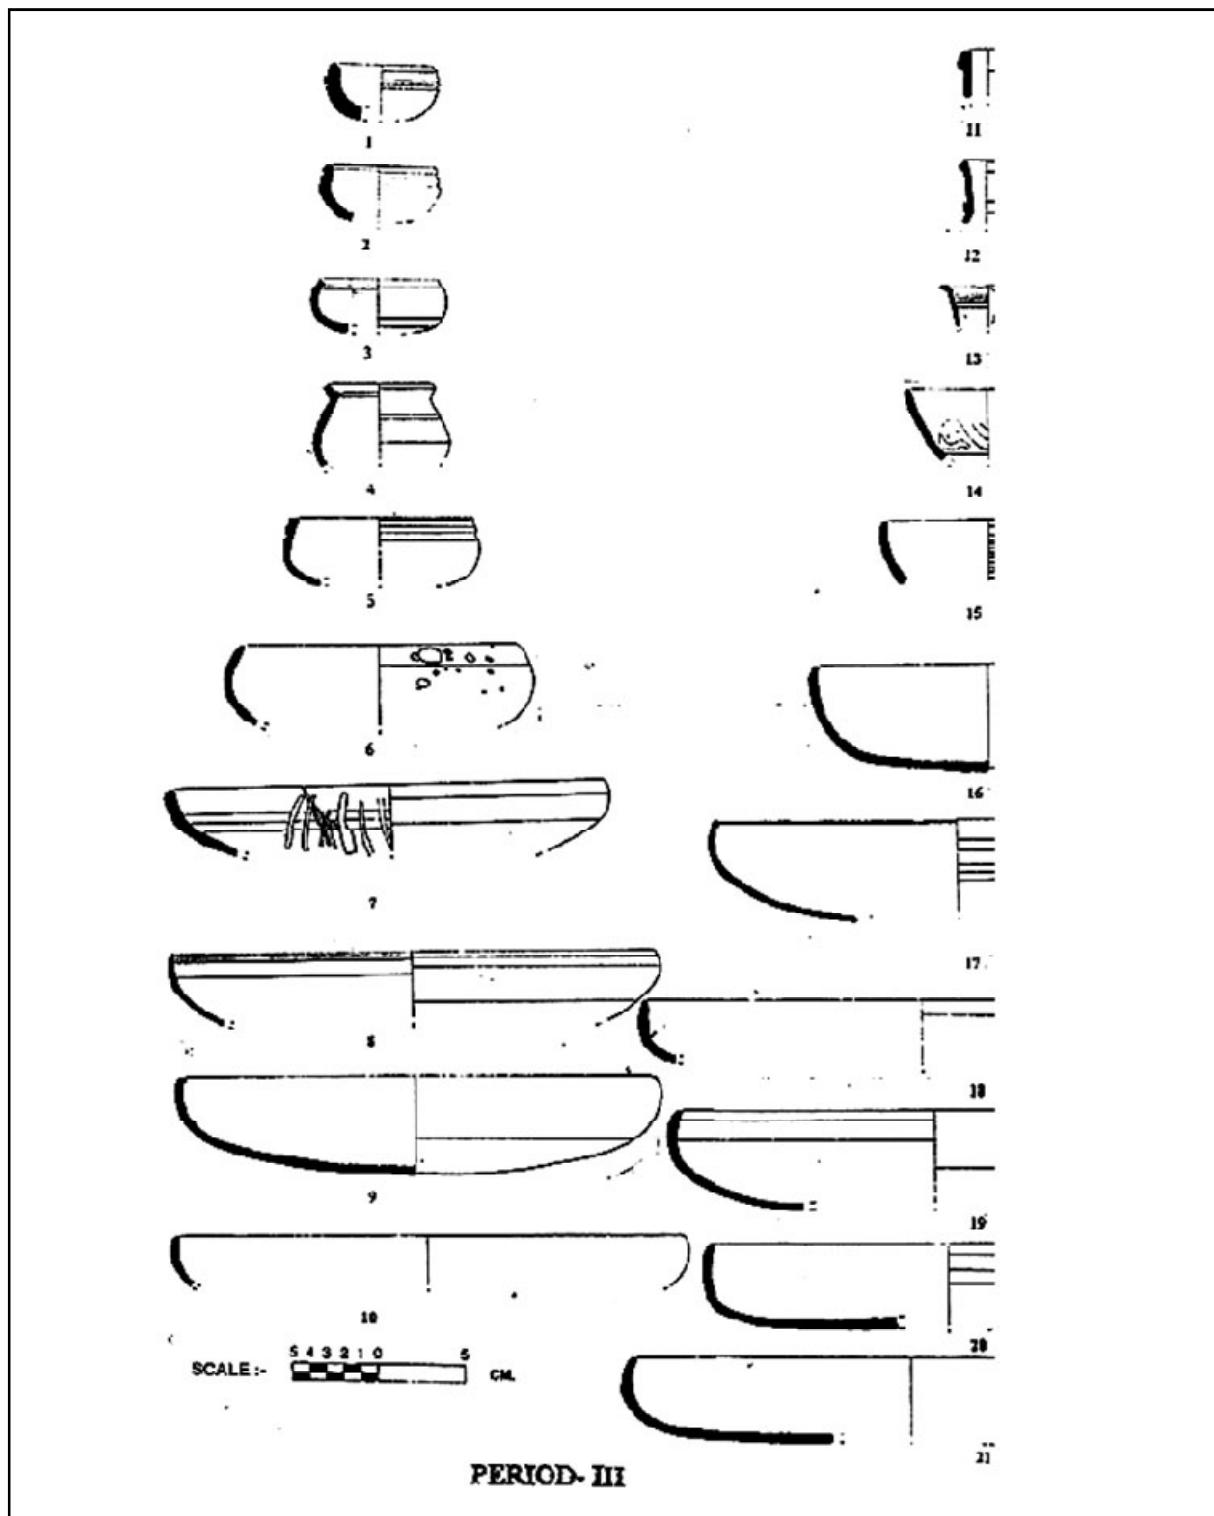
Fig. 5: Juafardih: NBPWares. See p.7

Period III is represented by 2.04m thick of red ware occupational deposit. The potteries of this period are characterized by the occurrence of red ware, dull red ware and red slipped ware. From Layer 1 to 5 the discovered potsherds have mixed in nature. A few shreds of black and red ware, huge amount of NBPW, and grey ware found at together (**Figs. 5-8**).

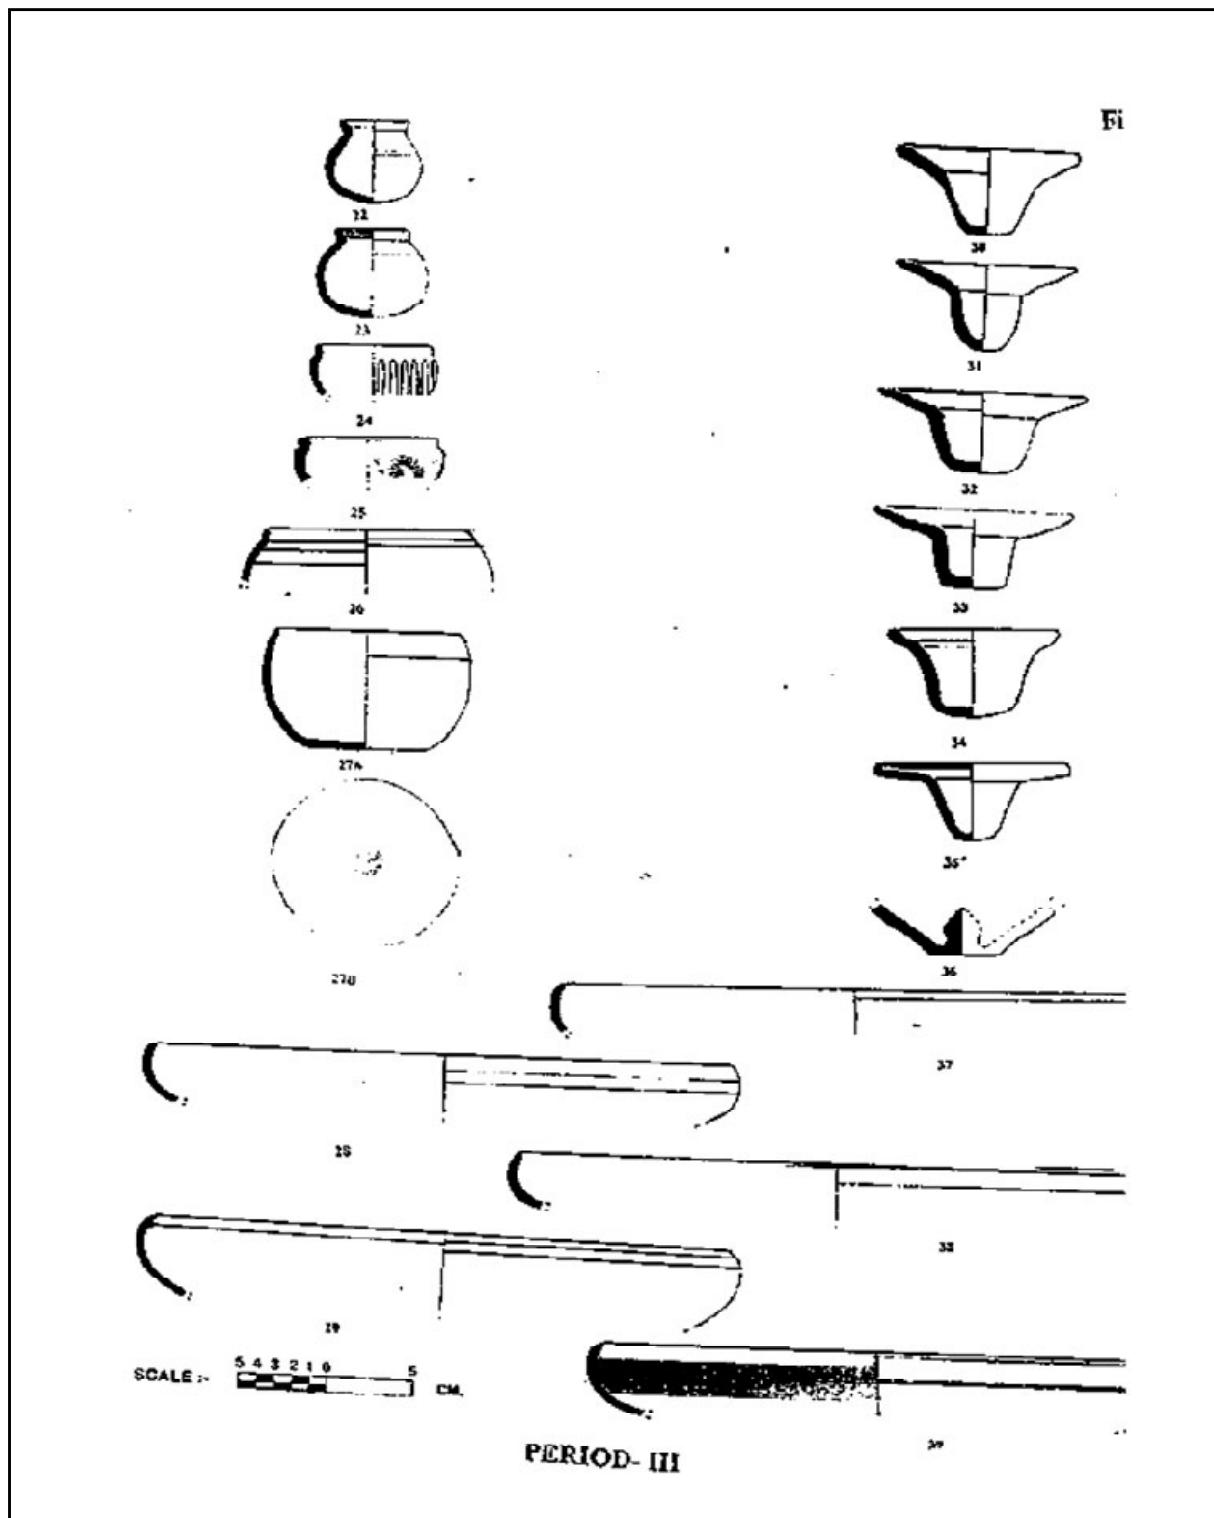
Fig. 6: Juafardih: Black and red ware and grey ware. See p.7

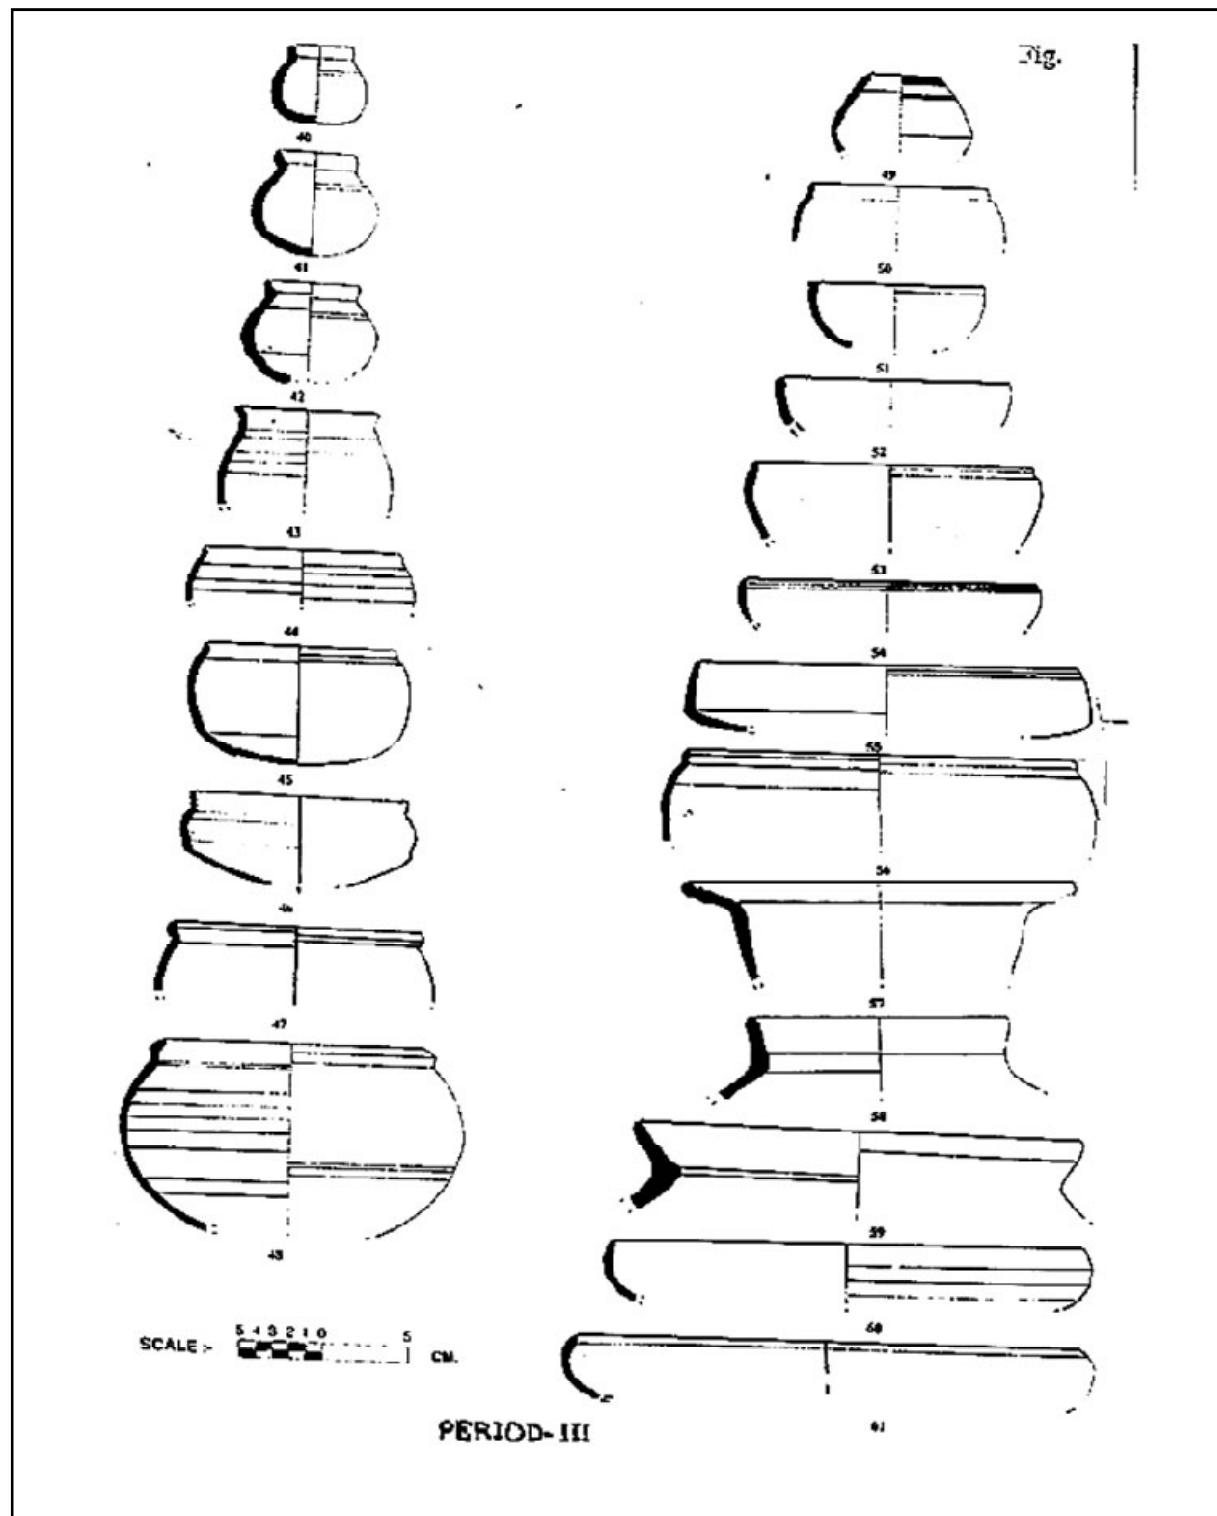
Fig. 7: Jufardih: Black and red ware. See p.7

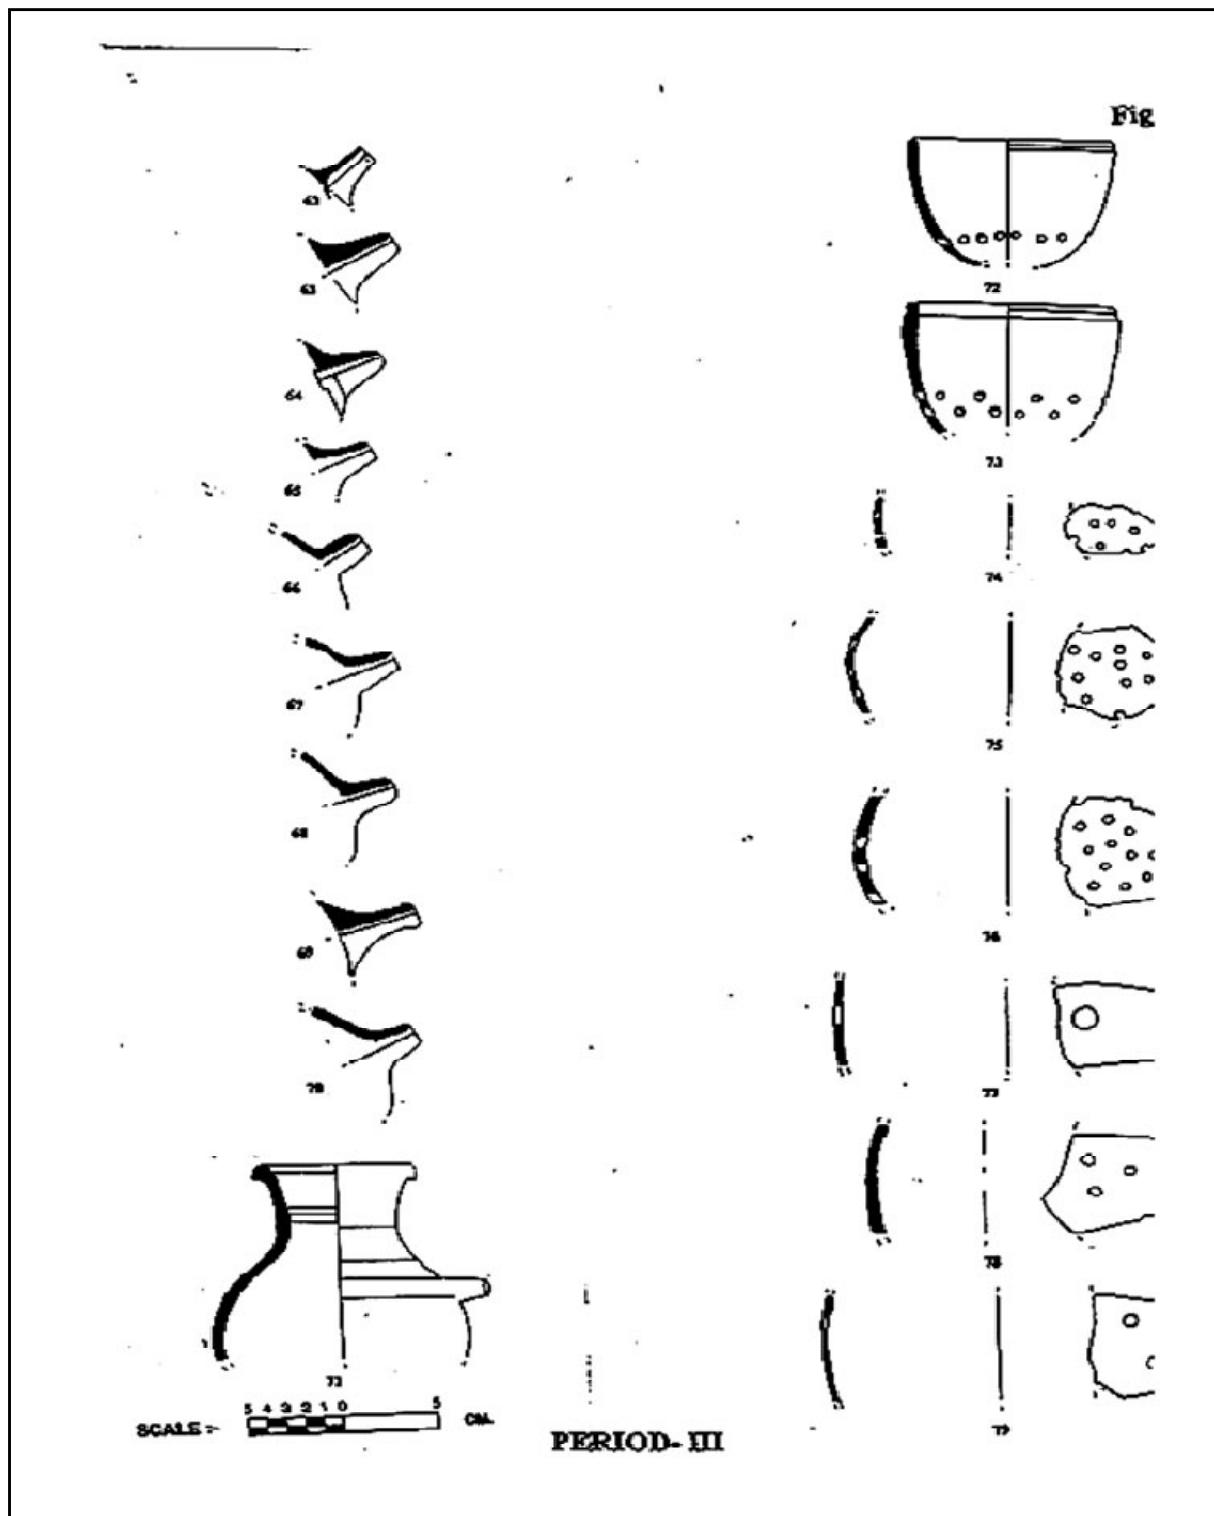
Fig. 8: Juafardih: Grey ware. See p.7

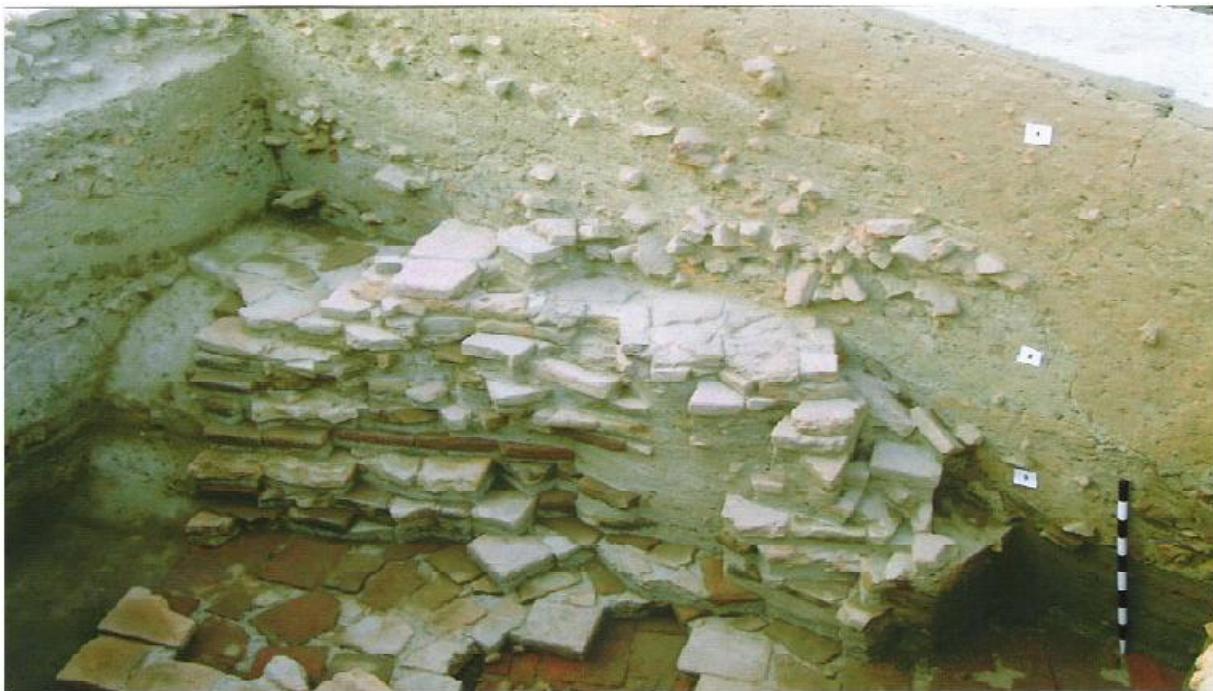
8

*Juafardih: 7 and 8, brick paved pradakshinapatha of stupa and burnt-brick encasing wall of stupa Period III,
See p. 7*

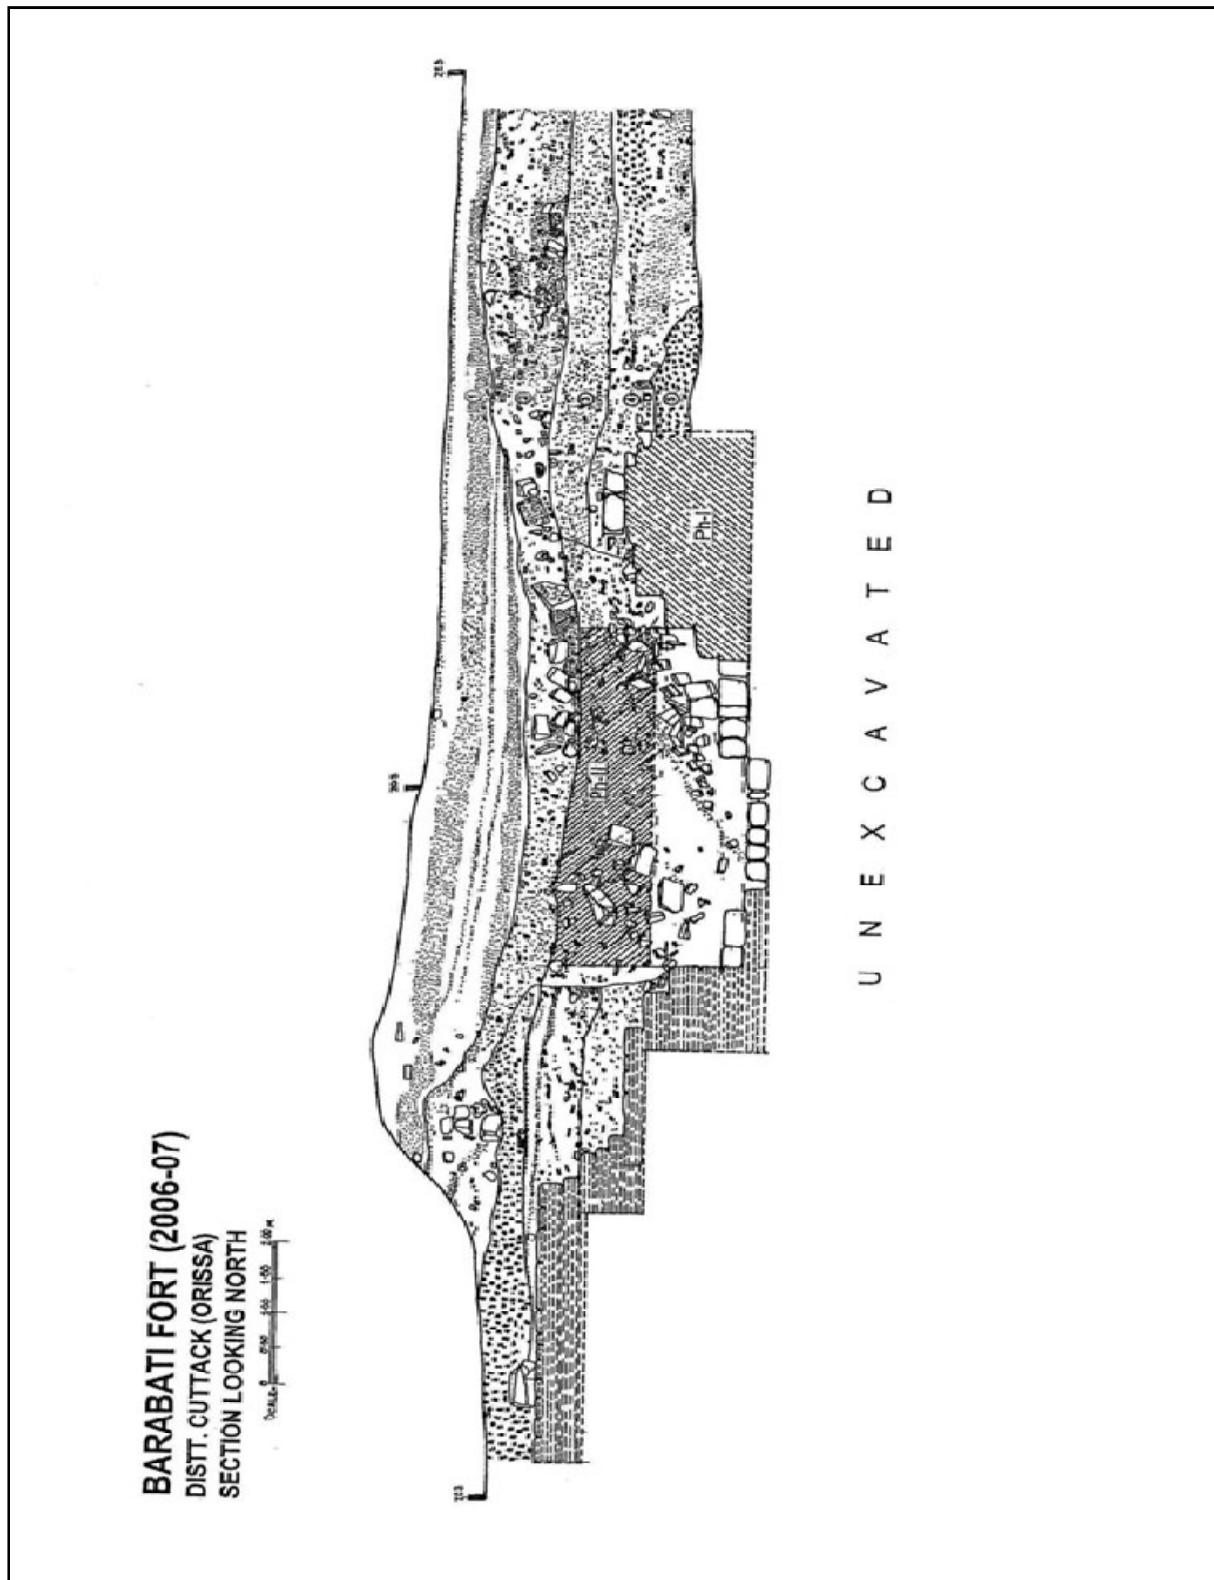
Fig.9: Barabati fort, Cuttack: Excavated section looking north. See p. 55

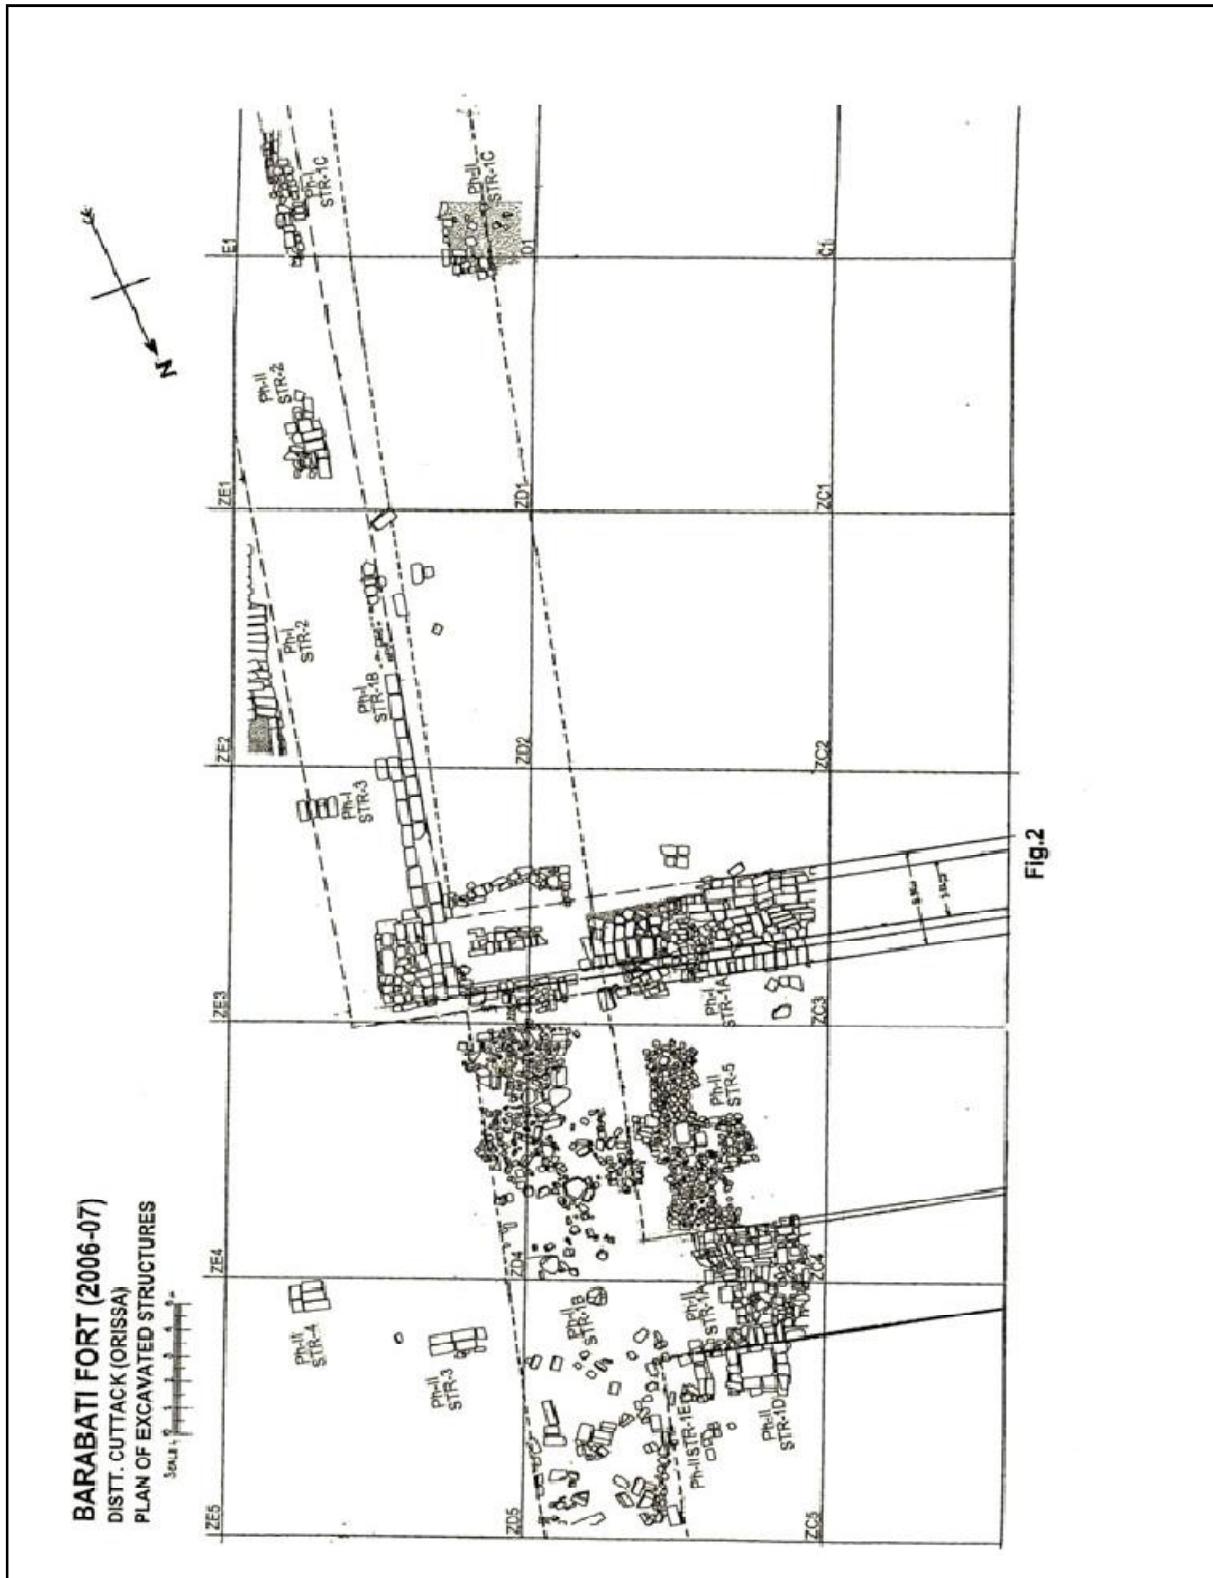
Fig.10: Barabati fort, Cuttack: plan of excavated structures. See p. 55

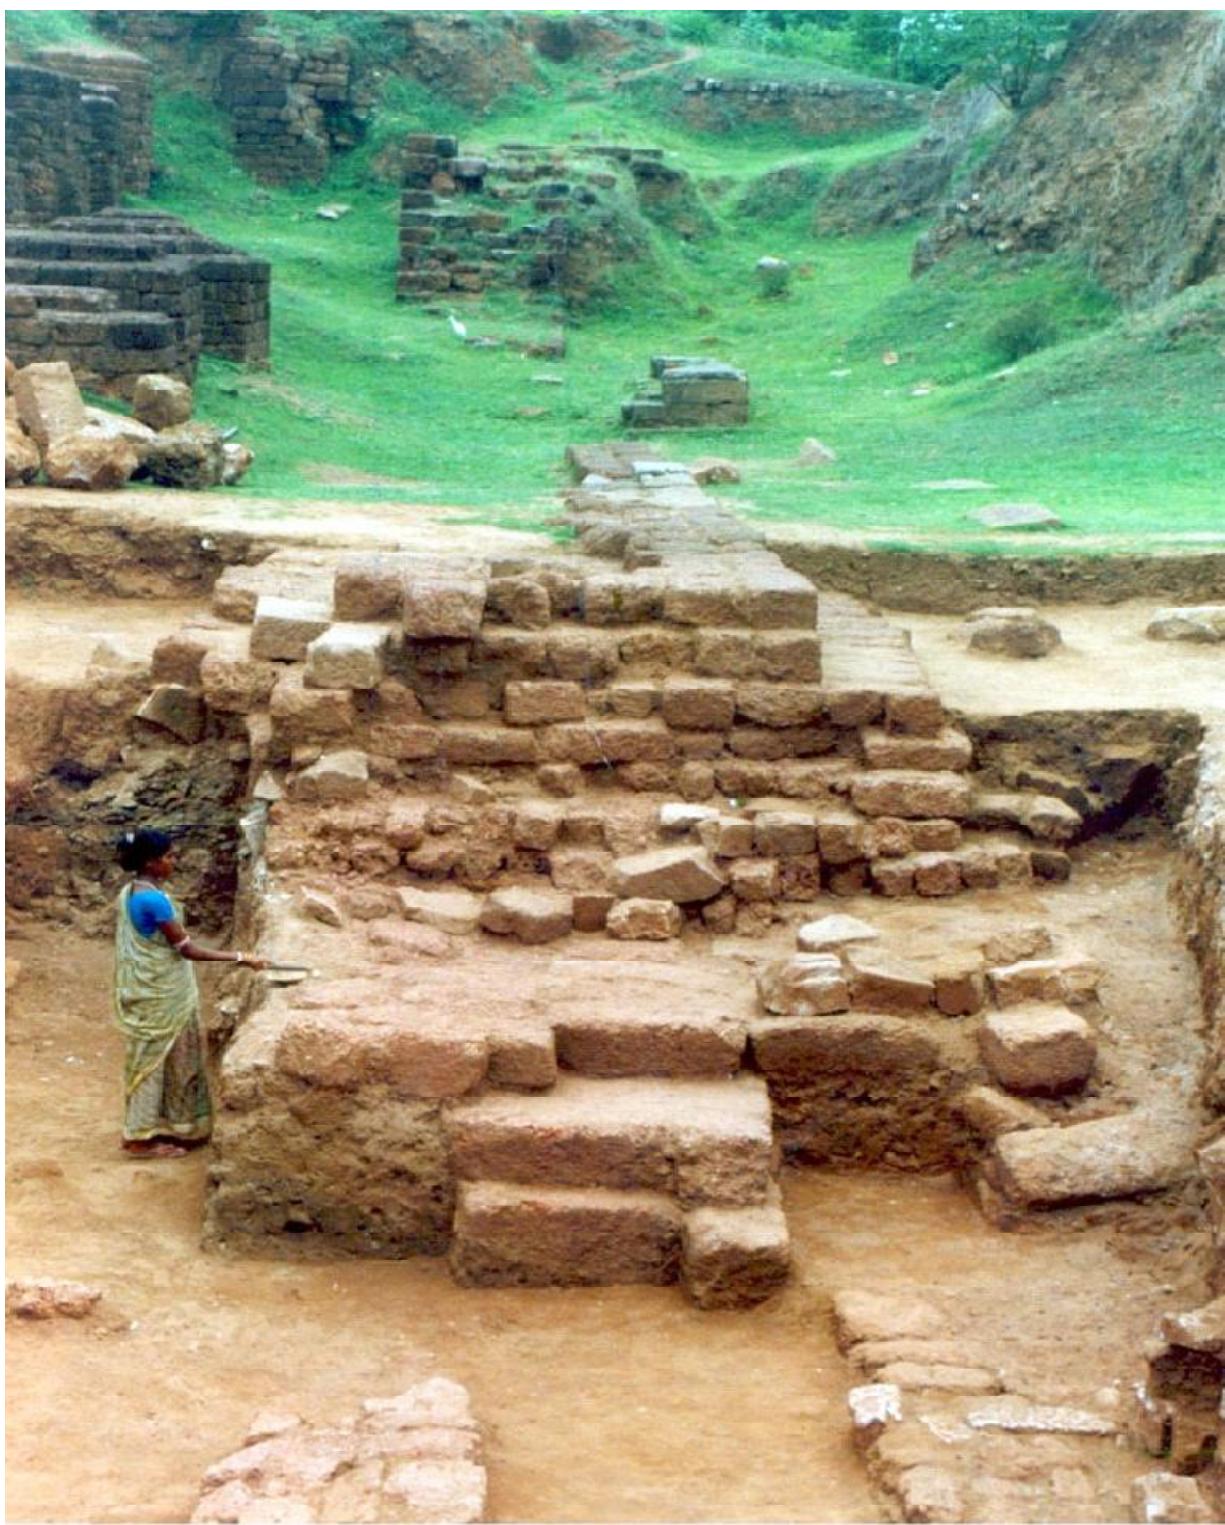
Barabati fort, Cuttack: excavated extension of corridor wall (phase I). See p. 55
