INDIAN ARCHAEOLOGY 2006-07

- A Review

PUBLISHED BY
THE DIRECTOR GENERAL
ARCHAEOLOGICAL SURVEY OF INDIA
JANPATH, NEW DELHI
2016

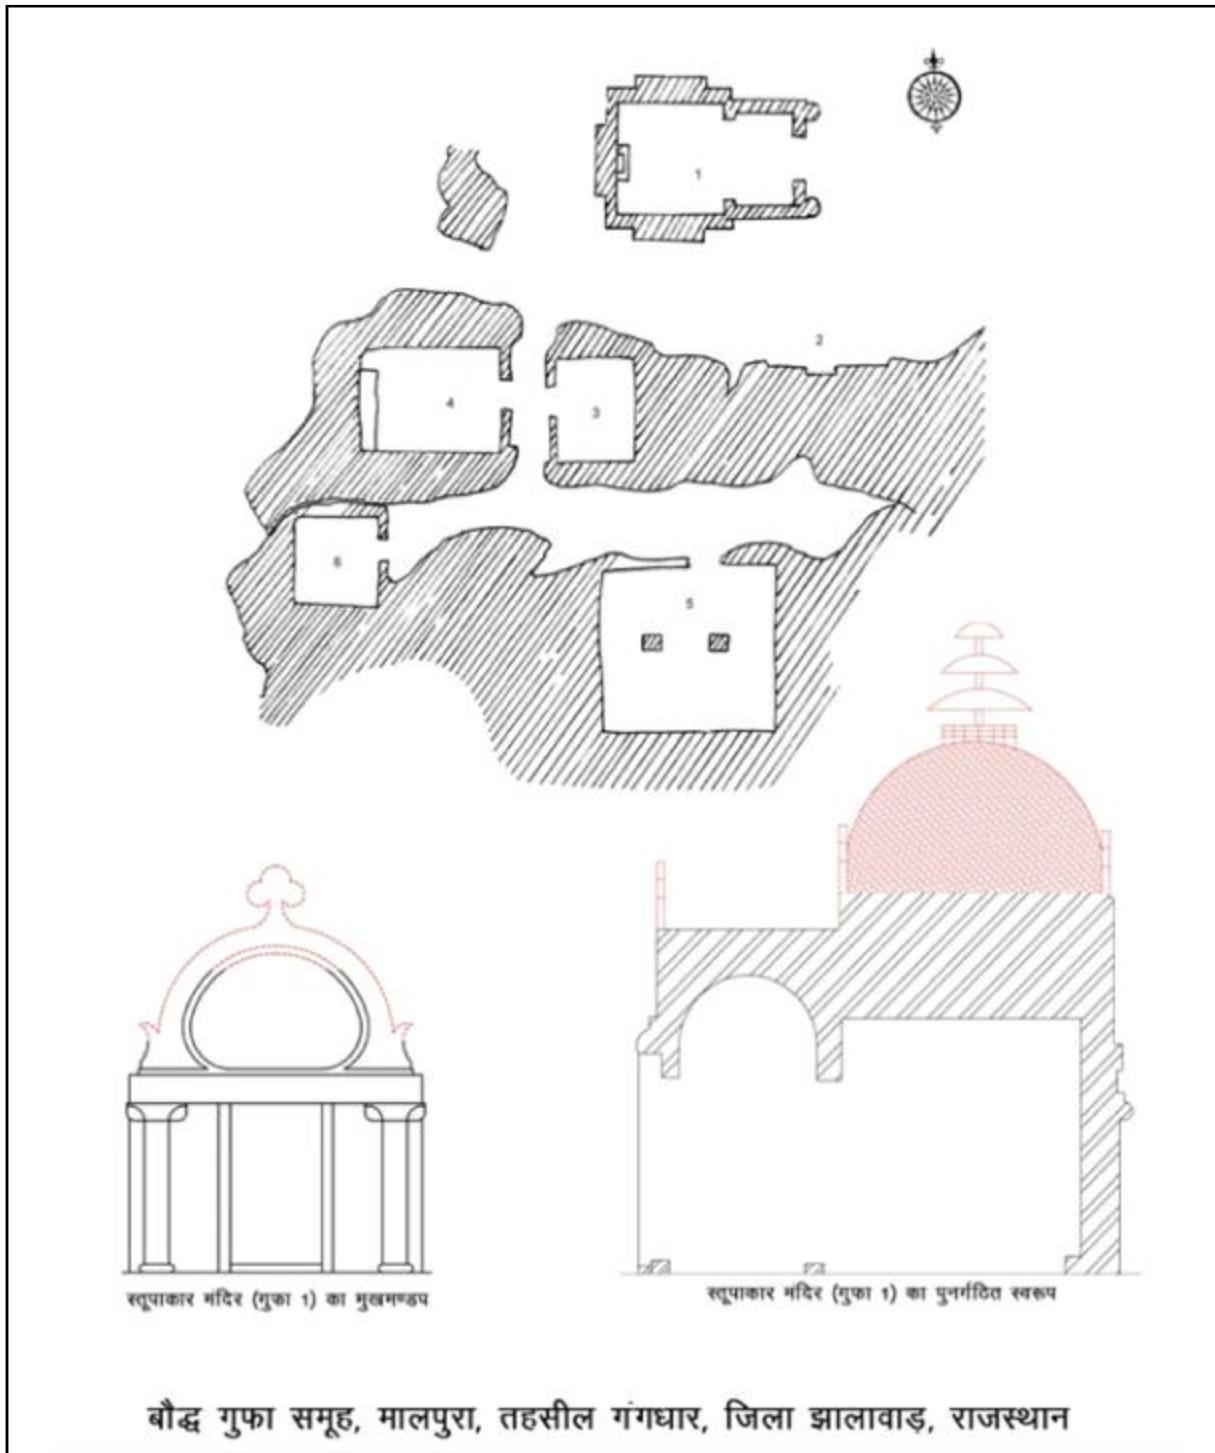
Fig.11: Malpura: Sketch-site plan of the caves and reconstructed front elevation and sectional-elevation of Cave 1 (stupa-shaped shrine). See p. 90

Rajendra Yadav of the Rajasthan State Archaeology and Museums, has discovered a group of five rock-cut caves at Malpura ($75^{\circ} 48' N$; $24^{\circ} E$), Rajasthan 2.5km south of Kolvi and 14km north of Dag in tehsil Gangadhar. The area is an extension of Malwa plateau marked by several small lateritic hillocks and seasonal rivulets originated from the hilly slopes and finally meet to river Kyasari which is flowing near village Kolvi. A small hillock named as Bhutadia is situated about 200m south of village Malpura revealed evidences of six rock-cut caves which are now in ruined condition (Fig.11).

The caves are excavated in the flat topped lateritic formation on Bhutadia hill which are modest in size. Out of six, four caves are monasteries, one is stupa-shaped shrine and one is left incomplete. These monastic excavations are small and roughly square or rectangular on plan entered through a small entrance. The monastic excavation of Cave 5 is the largest measuring 5x4.6m while the smallest Cave 3 measuring 2.33x2.87m is in size. The interior walls of the caves are unfinished but plastered with mud mixed with cow dung, *murrum* and hay. The Cave 4 is rectangular in shape measuring 4x2.90m. The dilapidated Cave 1 is a stupa-shaped shrine is most important among them. Located on the northern edge of the hillock, it is carved from a large isolated lateritic hillock from internally and externally like a temple. Facing east, the shrine consists of a square sanctum and an anti-chamber on the axial plan with an entrance on the east. Outwardly, in elevation the shrine has a moulded square platform with side projections on cardinal directions, an elongated

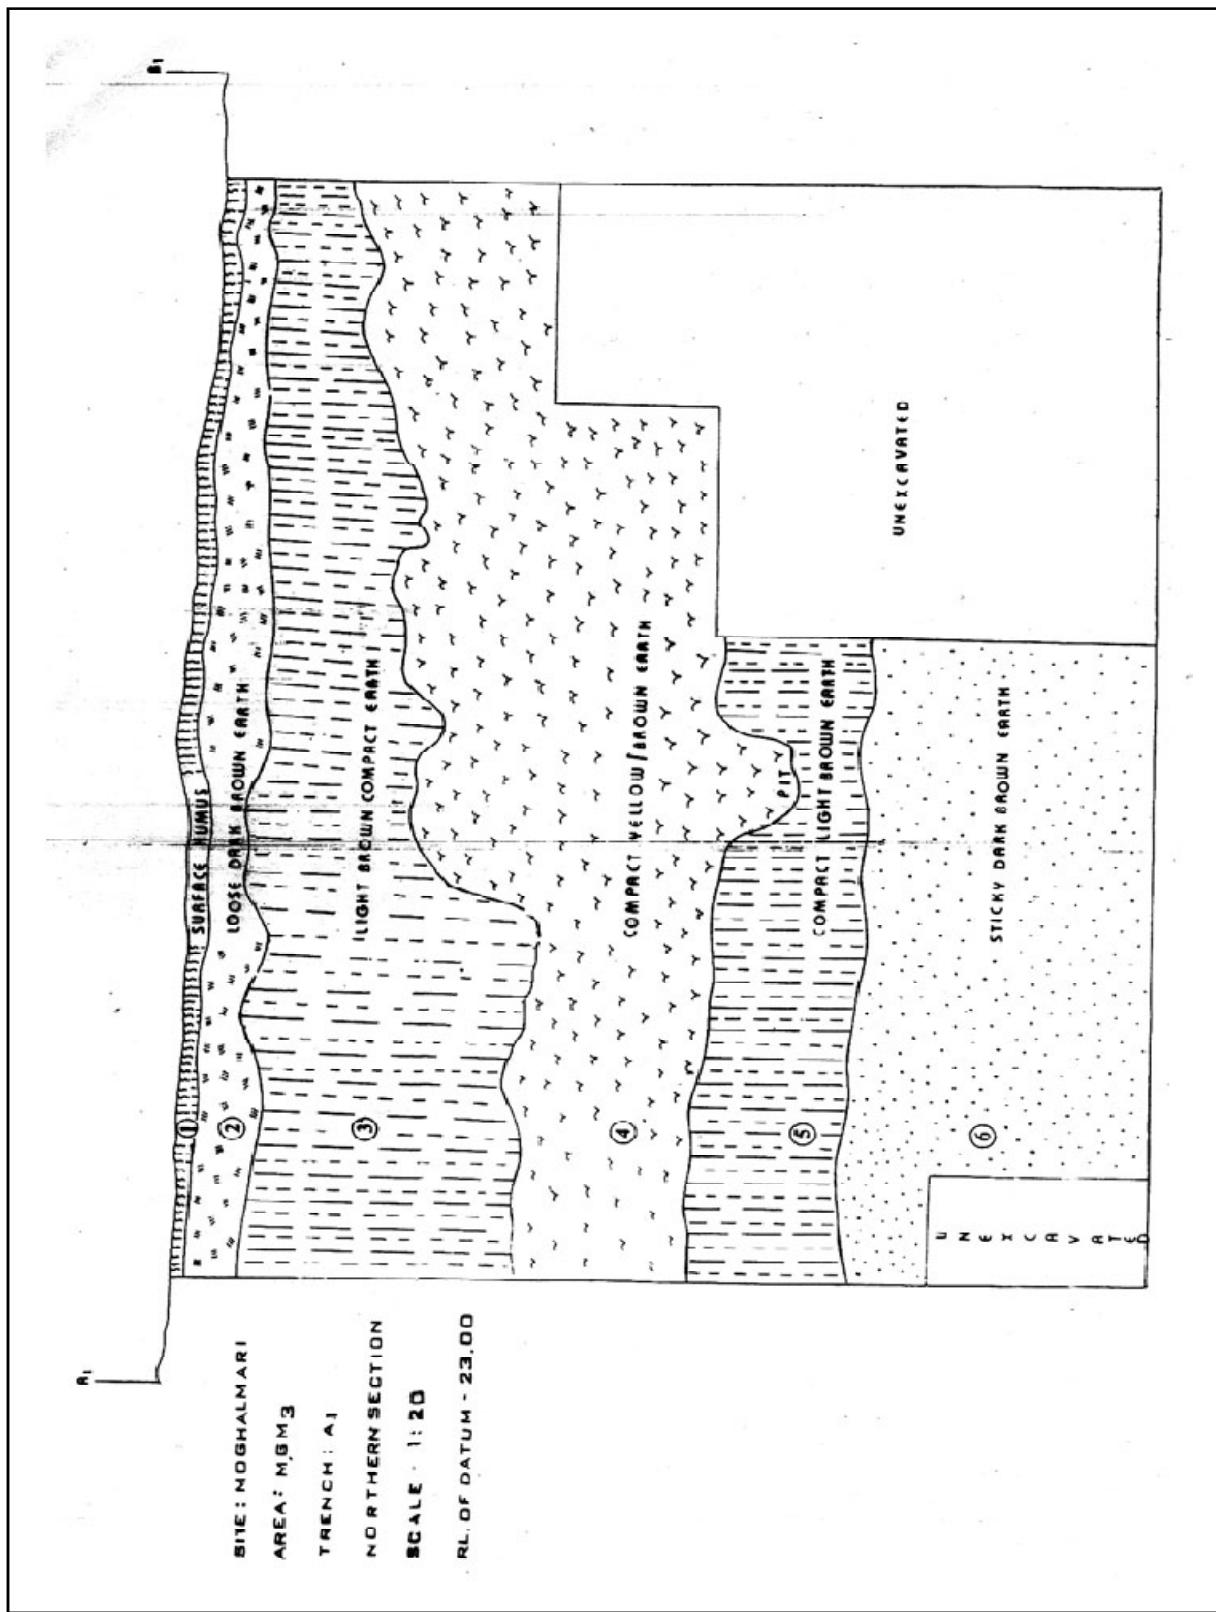
Fig. 13: Maghalmari section. See p. 140

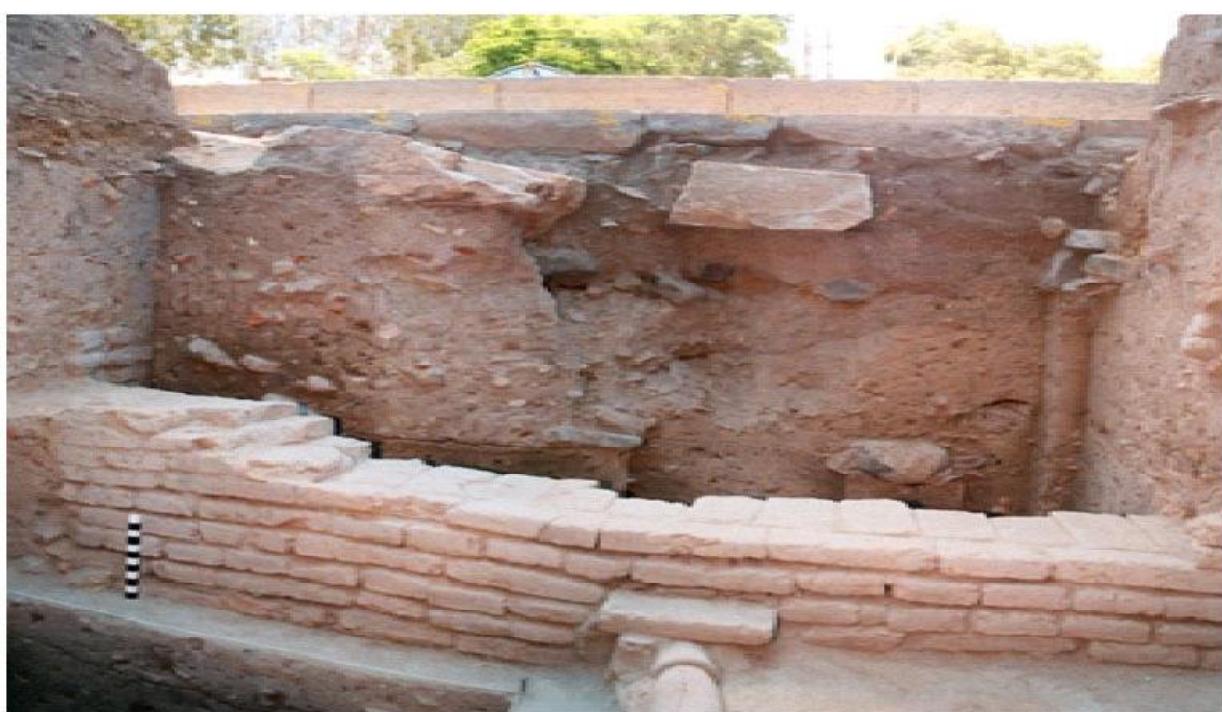
84

Keertinarayana temple, Talakad: 84, Trial trench, Ganga period brick structure; 85, Nature of foundation deposit, garbhagriha. See p. 154

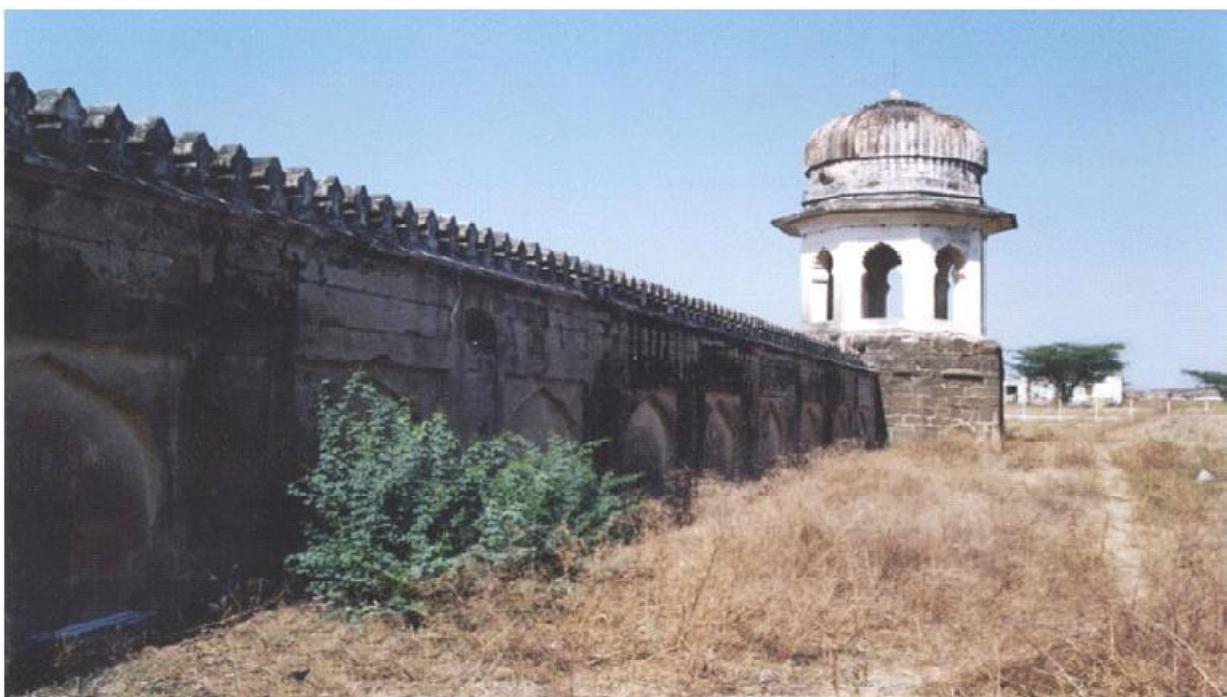
90

Bibi-ka-Maqbara, Aurangabad: 90, before; 91, after replacement of plaster of eastern enclosure wall, See p.171

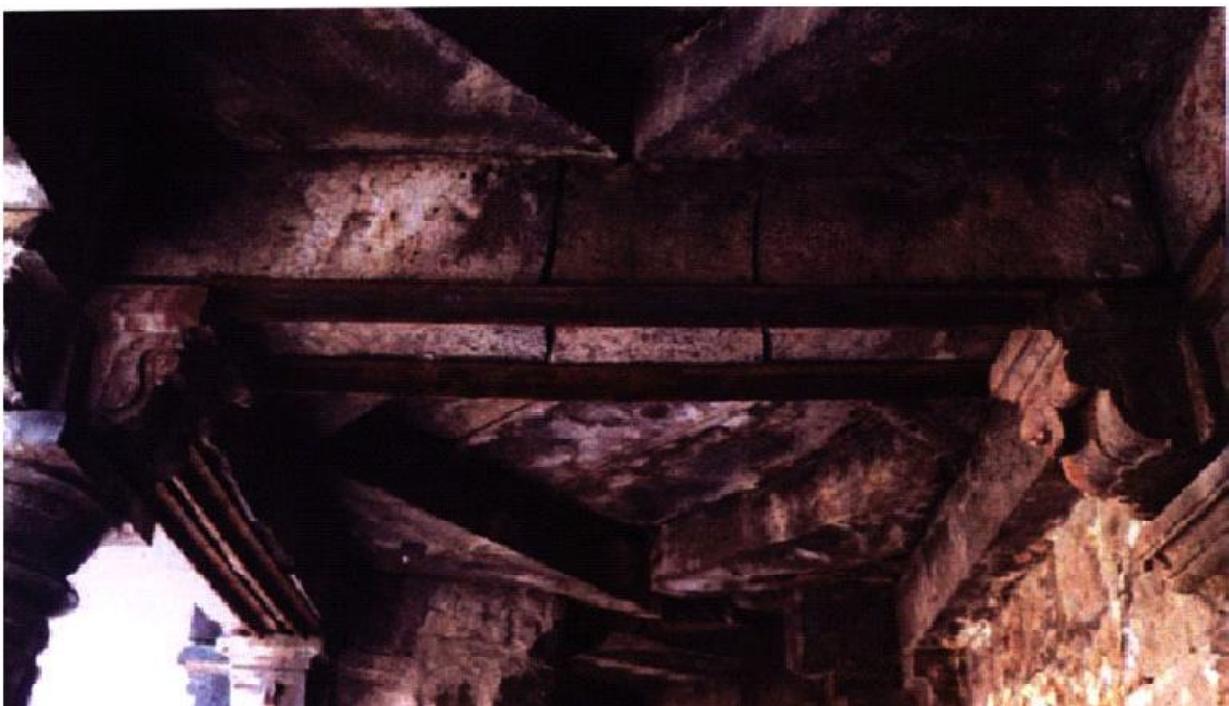
98

Daityasudana temple, Lonar: 98, before; 99, after replacement of broken beams. See p. 178

In continuation of previous year's work of replacing the broken beams and *chhajjas* with new stones of similar sizes has been carried out

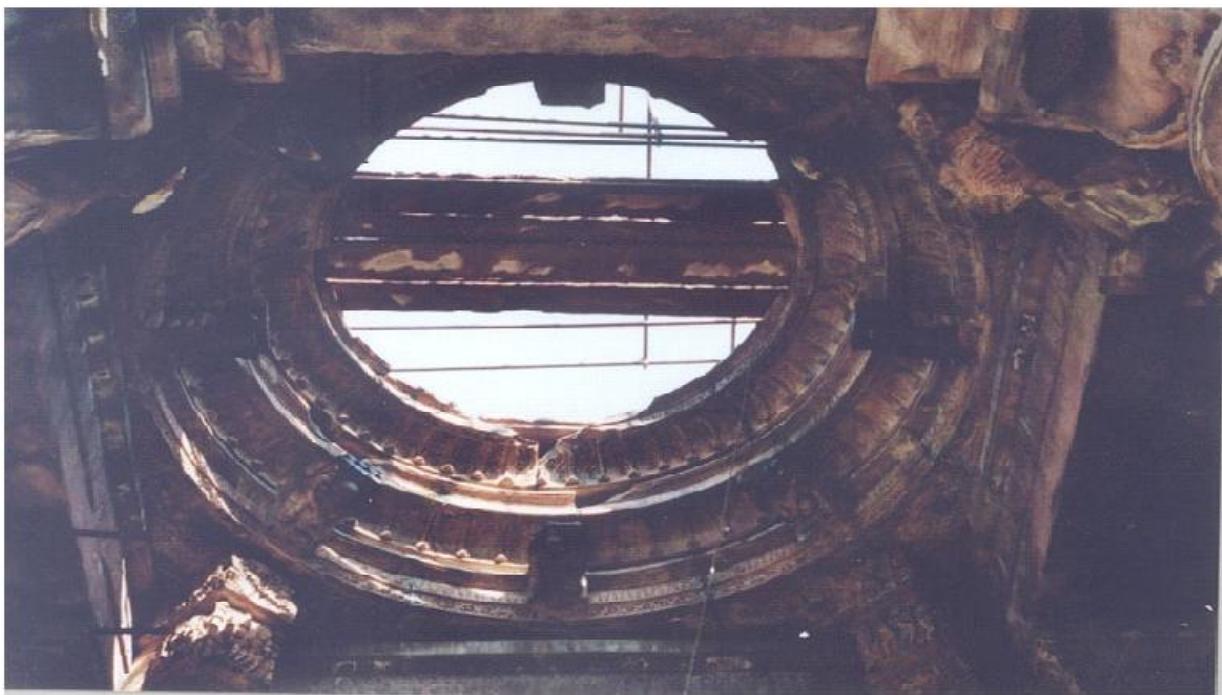
135

Siva Temple, Bhojpur: 134, general view showing the dilapidated condition and 135, open ceiling of the temple. See p. 198

The open ceiling has been covered with a fibre moulded architectural member, matching with the designs of the original ceiling member (Pls. 134-135). This has not only stopped water percolation into the temple but also reduced the unnecessary weight on the top of the temple, which could have damaged the entire structure. The gap portion between the wall and the temple superstructure through which rainwater was pouring inside was covered by placing slanting stone slabs according to the available evidences (Pls. 136-137). Apart from this on the right side (north) of the temple entrance a large monolith of 3.52x1.40x0.80m in size and weighing about 15 tons has been placed at the missing place. The huge monolith with the help of chain pulley was raised to a height of about 6m from the platform level of the temple and was placed within the given space (Pls. 138-139).

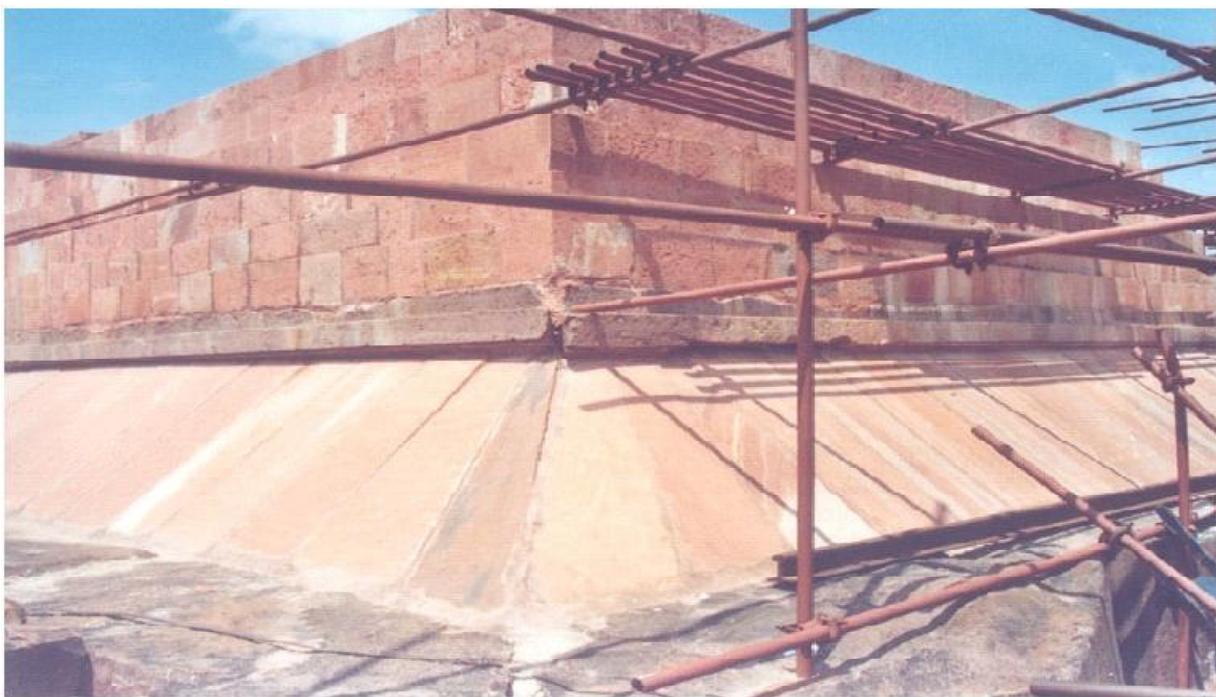
139

Siva temple, Bhojpur: 138, view showing the missing member on the right side (north) of temple entrance and 139, after restoration of slanting slabs at the top of the temple. See p.198

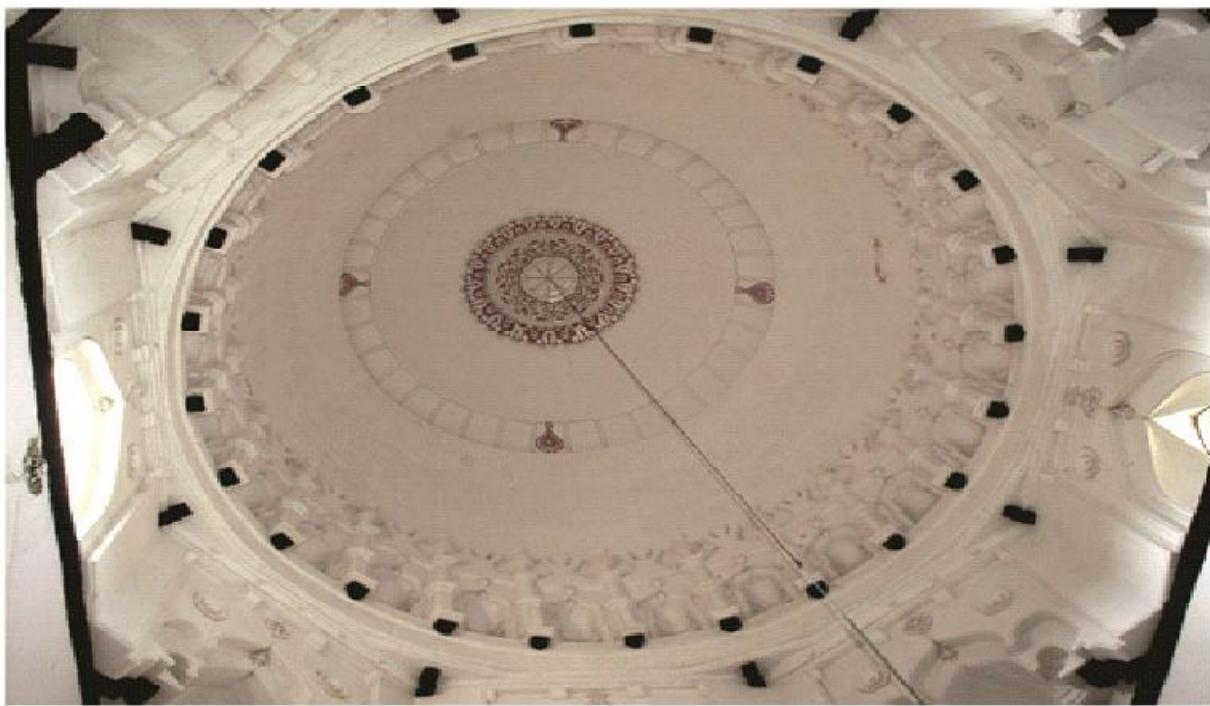
191

Great mosque, Gulbarga: 190, before and 191, after the repairing of stucco work. See p. 243

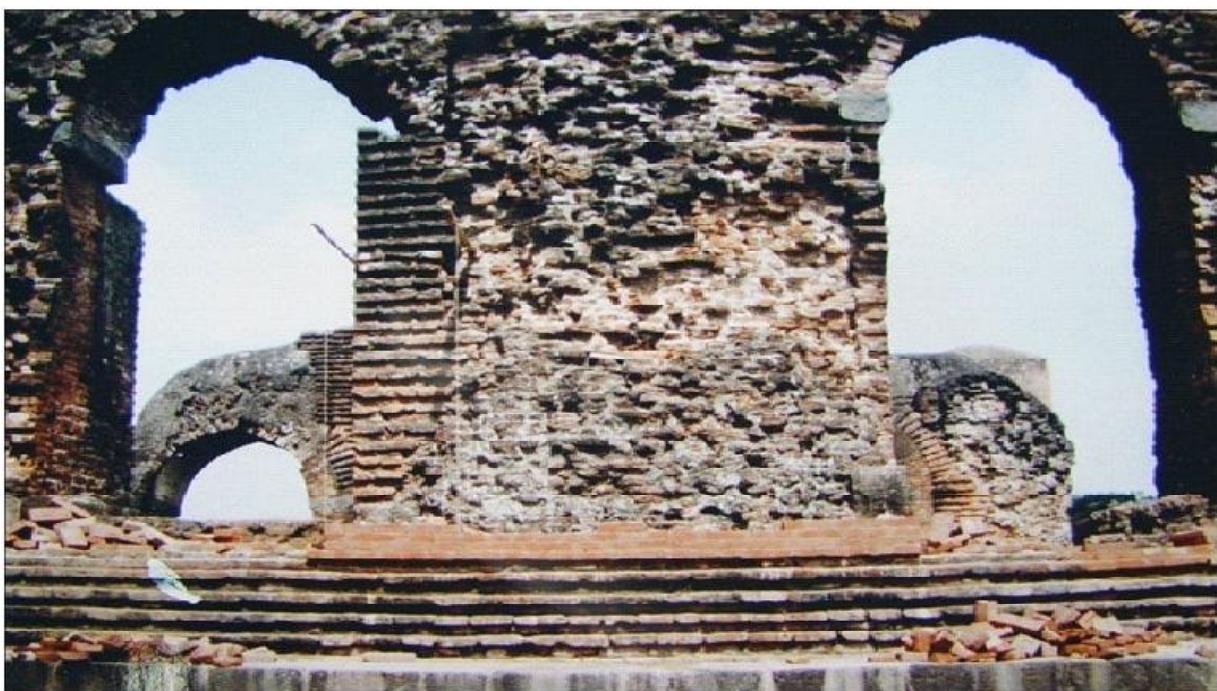
216

Adina Masjid, Pandua: 216, before and 217, after repair of brick masonry. See p. 275

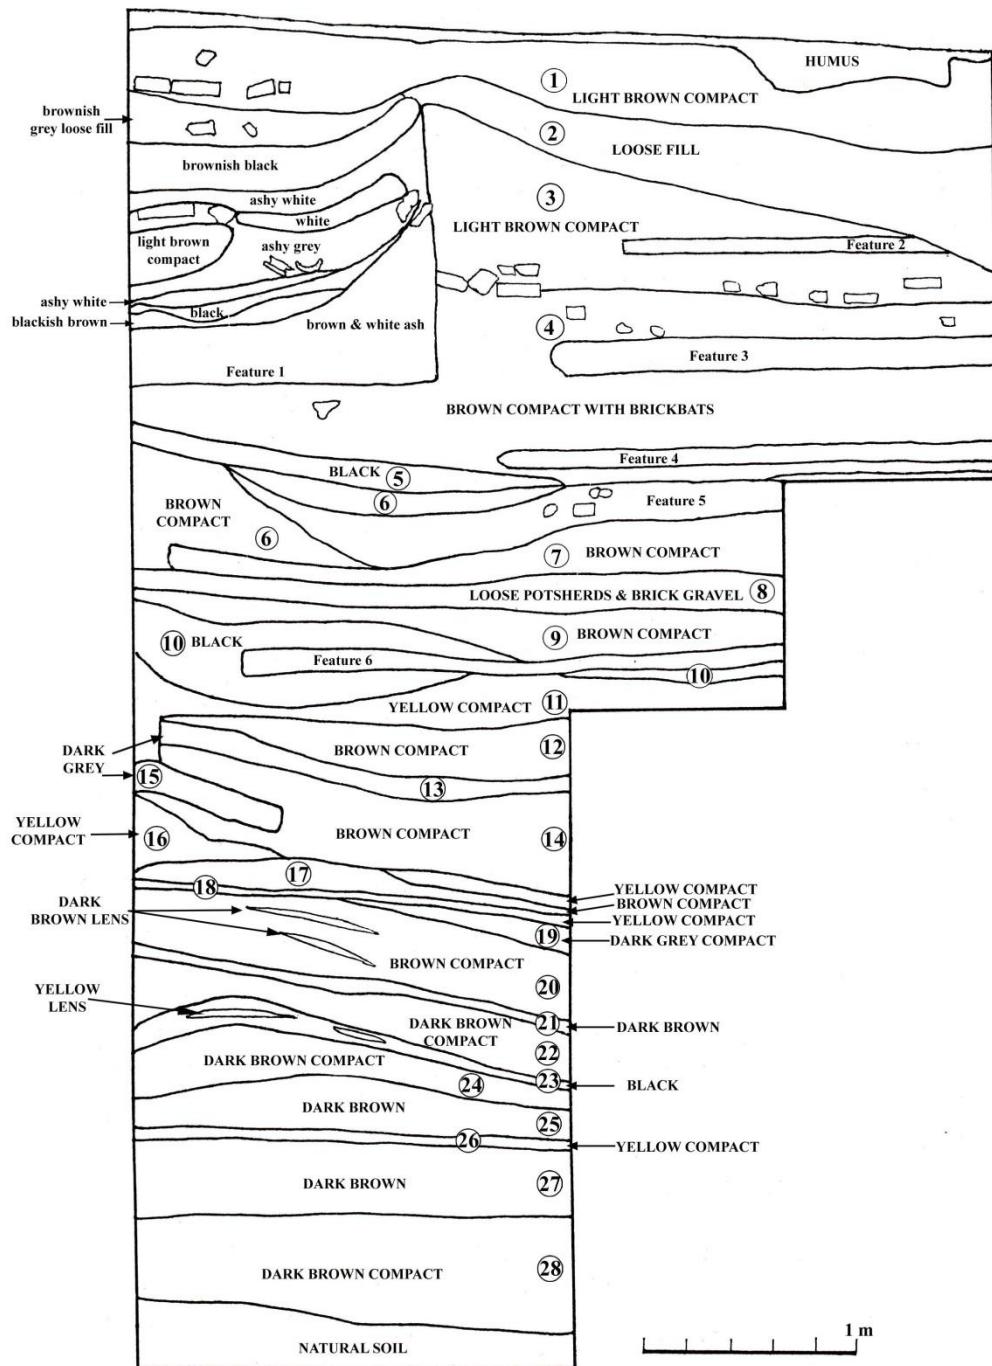
Fig. 2

Indor Khera: South facing section of A3.

remaining four were paved (**fig. 2**). These successive roads in Period II were probably originating from a gateway perhaps at the gully near A3.

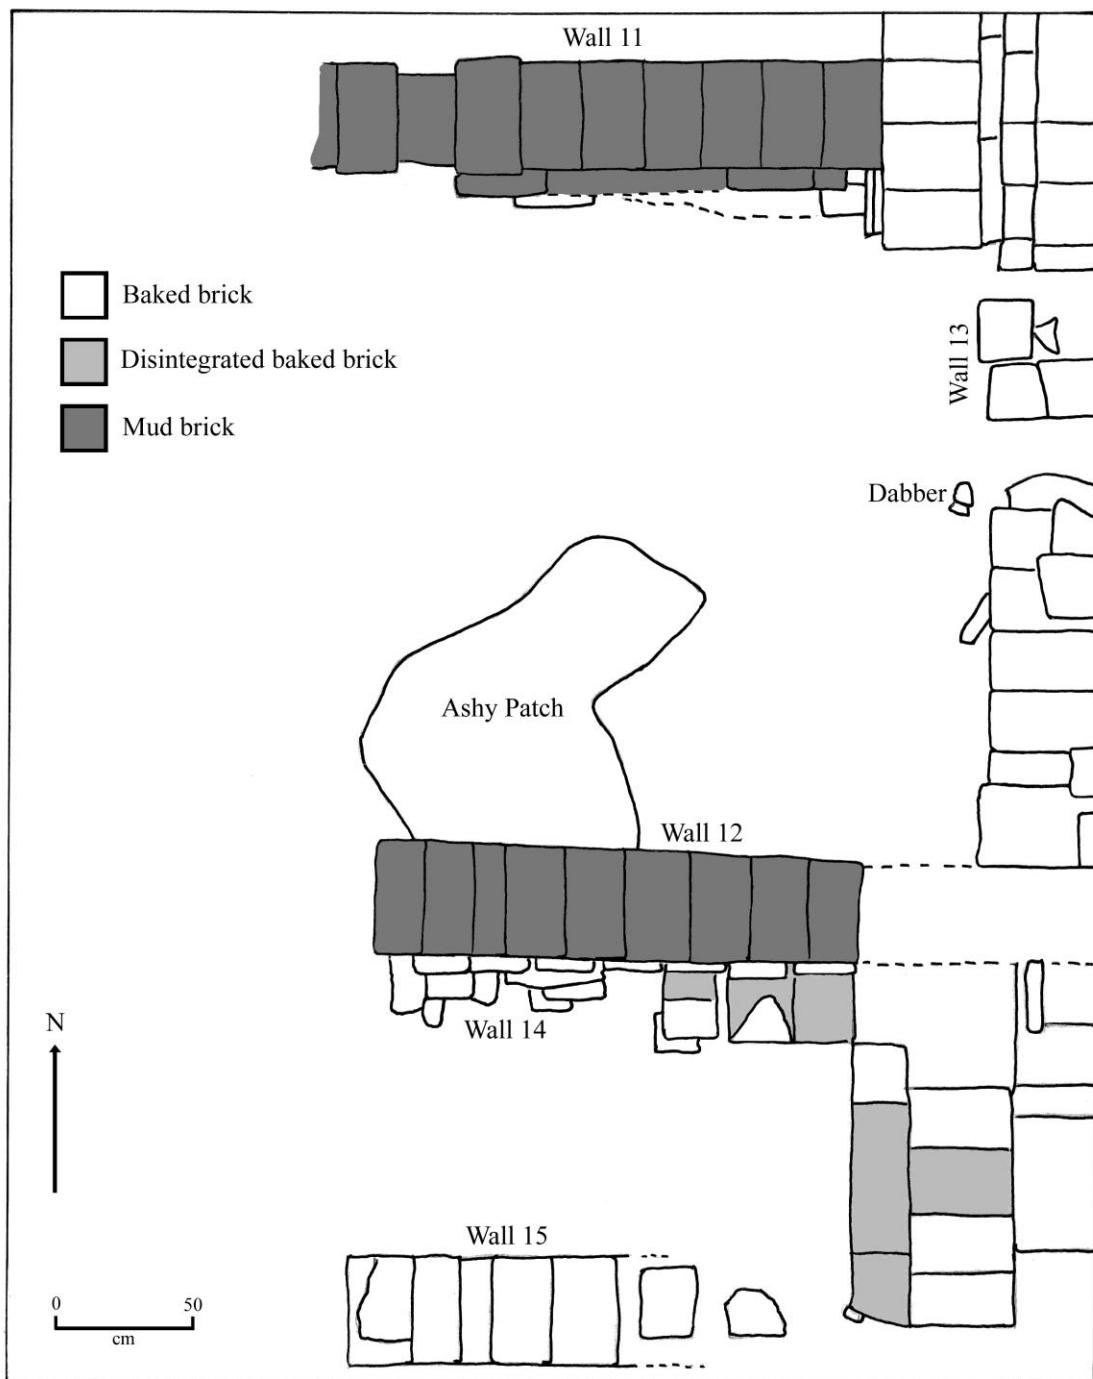
Fig. 5

Indor Khera: Plan of B1a and part of B1d.
