## Indian Archaeology 2007-08

## - A REVIEW

PUBLISHED BY THE DIRECTOR GENERAL ARCHAEOLOGICAL SURVEY OF INDIA JANPATH, NEW DELHI 2016

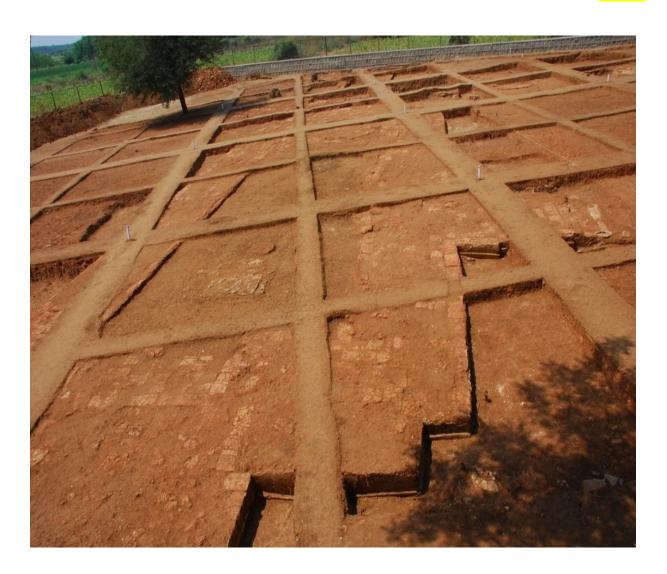
Alluru: remains of large stupa *chaitya* during excavation.

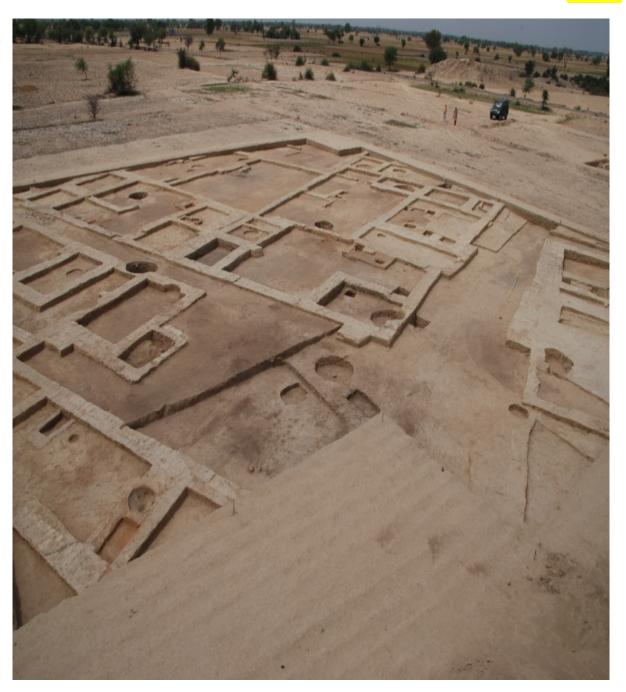
Farmana: remains of a planned settlement, mature Harappan.

planned Mature Harappan settlement at Farmana. All the structures of this period are now made of sun-dried mud bricks in the typical Harappan ratio of 1:2:4. The part of a typical chess-board type plan was excavated. To the west of the structural complex 1 excavated last year, was found the main street running in slightly northwestsoutheast direction, which is perfectly parallel to the outer wall of the structure complexes excavated so far. To the west of the main street were excavated three more structure complexes, all parallel to the Main Street and parallelogram on plan; structure complex 3, just opposite to the west of structure complex 2 and separated by the main street, is the largest amongst all of the structure complexes excavated at Farmana so far. This structure complex, oriented parallel to the main street, consists of many rooms, 22 of which of different sizes and shapes have been excavated so far. Some of the rooms are square and some rectangular on plan. Many rooms of this complex continue towards north and western sides, which are not dug yet. On the basis of contents these rooms could be inferred to have been used for a variety of purposes such as dwelling, storage, cooking and craftmanufacture. This structure complex has an opening near the south western corner in the form of a "L"-shaped passage. The rooms identified as dwelling have larger space and well made floors, rammed and plastered. The storage rooms are either small in dimension or contain storage pits. The kitchen part of the structure complex usually contains a rectangular fire-place and one or two medium to large size pots close to it. The entire complex was built around the

open courtyard located in the centre. The structure complex has not been excavated to its entirety as it extends both in the western and northern sections. The excavated portion of the complex was inhabited by at least seven different families. They may belong to one large extended family or closely related to each other.

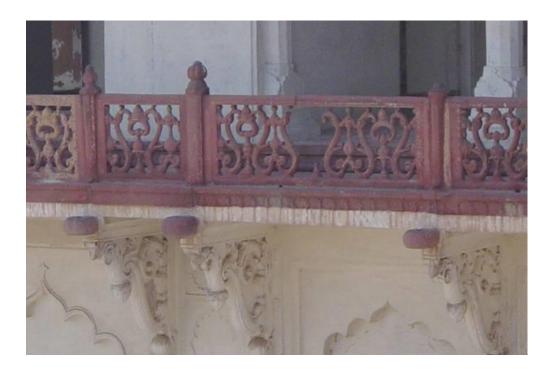
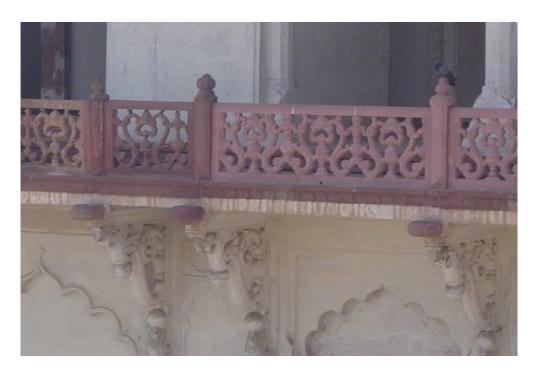
Angoori Bag: before and after conservation, broken red sand stone jali railing, Muttaka,

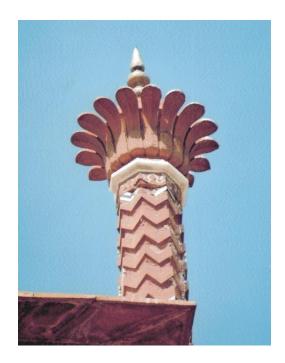
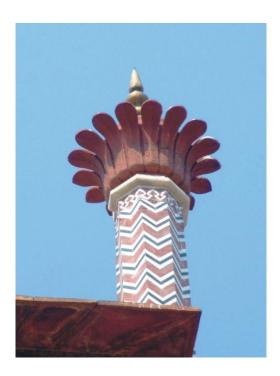
Taj Mahal, Agra: before and after conservation of missing inlays in turret of main entrance gate.

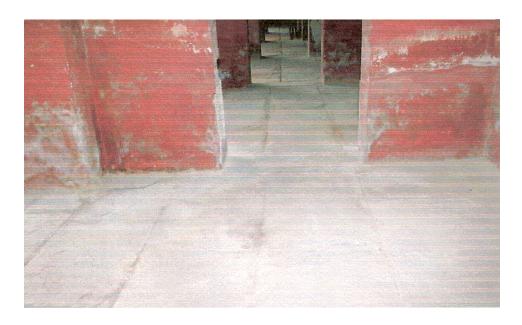
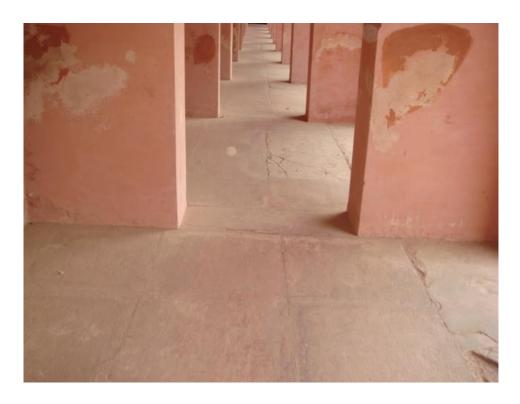
Taj Mahal, Agra: before and after conservation of damaged flooring of north-east dalan of Fore court.

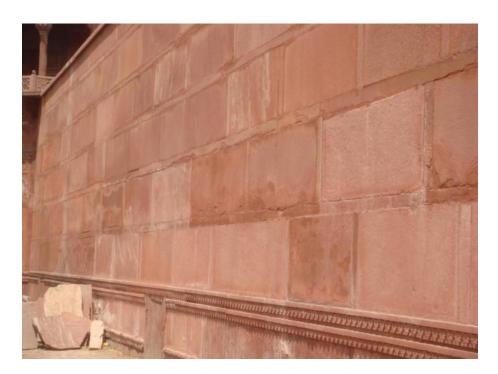
Taj Mahal, Agra: before and after conservation of western enclosure wall.

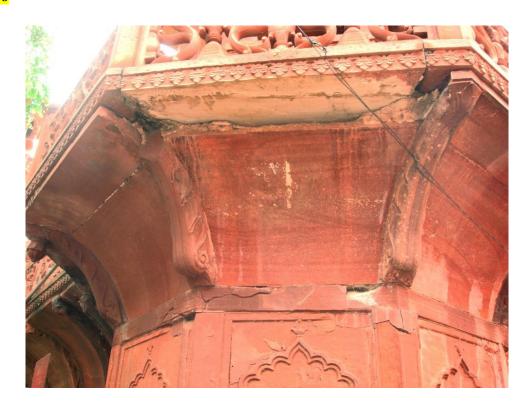
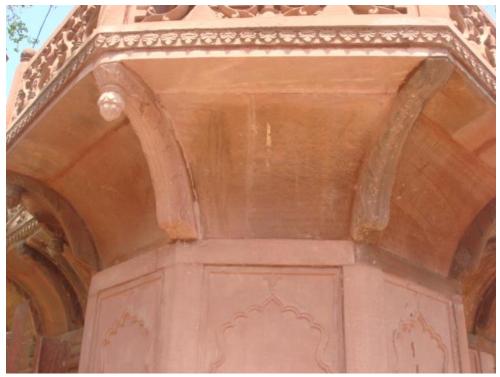
### <mark>Plate 96</mark>

Taj Mahal, Agra: before and after conservation of Fatehpuri mosque, broken and decyaed stones,

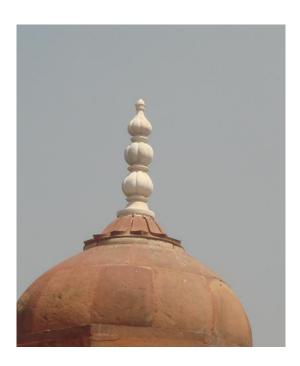
Taj Mahal, Agra: before and after conservation of Fatehpuri mosque, broken pinnacles.

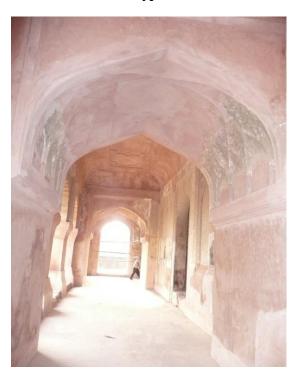
Tomb of Iklas Khan, Badaun: before and after conservation of cracked ceiling.

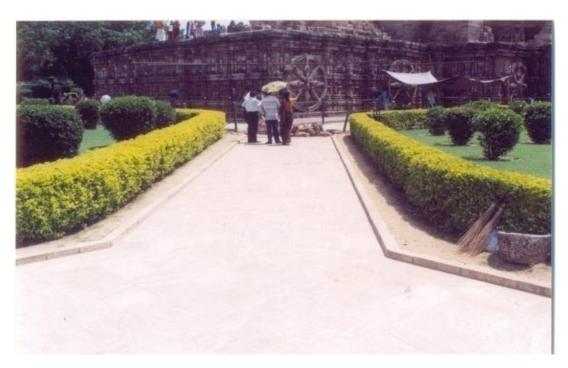
Sun temple, Konark: before and after conservation of the damaged floor on the northern side.

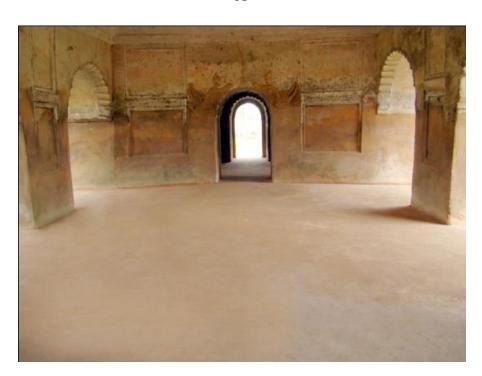
Ranghar Ruins, Joysagar: before and after repairs of the flooring.
